Inspection Report

| Site; Tye Lane<br>Place: Warblington | | Division:<br>District: S.W<br>Tape No: 1 | | Start MH: F31.1D<br>End MH: LAT 1<br>Total Length: | |

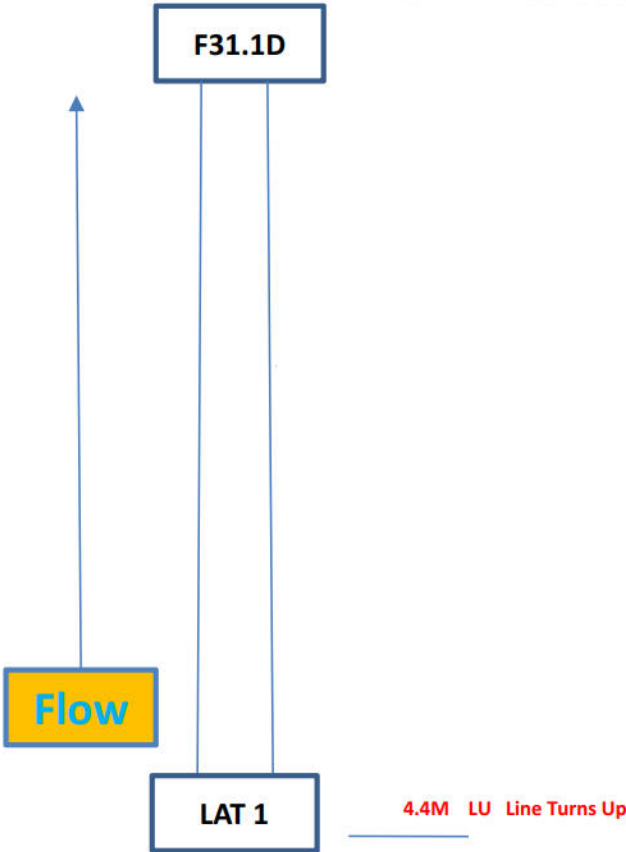
0.0M ST Start Of Survey  
0.0M WL Water Level 0%

REM ; THERE ARE NO DEFECTS WITH THIS SECTION OF PIPE
