Inspection Report

| Site; Tye Lane<br>Place: Warblington | | Division:<br>District: S.W<br>Tape No: 1 | | Start MH: F31.1D<br>End MH: LAT 2<br>Total Length: | |
| Purpose:<br>Use:<br>Catchment: | Structural Defects<br>FOUL<br>P1 Schedule | Size/Shape: Circular dia 100mm<br>Material: PLASTIC<br>Lining:<br>Category: | | | |

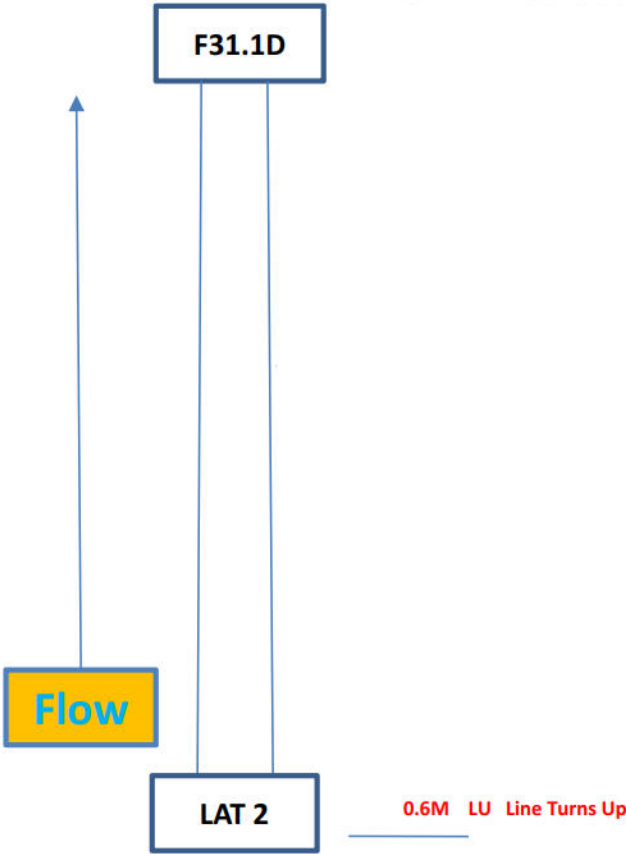
0.0M ST Start Of Survey  
0.0M WL Water Level 0%

REM ; THERE ARE NO DEFECTS WITH THIS SECTION OF PIPE
