Inspection Report

| Site; Tye Lane<br>Place: Warblington | | Division:<br>District: S.W<br>Tape No: 1 | | Start MH: F31.1D<br>End MH: F31.1C<br>Total Length: | |
| Purpose:<br>Use:<br>Catchment: | Structural Defects<br>FOUL<br>P1 Schedule | Size/Shape: Circular dia 100mm<br>Material: PLASTIC<br>Lining:<br>Category: | | | |

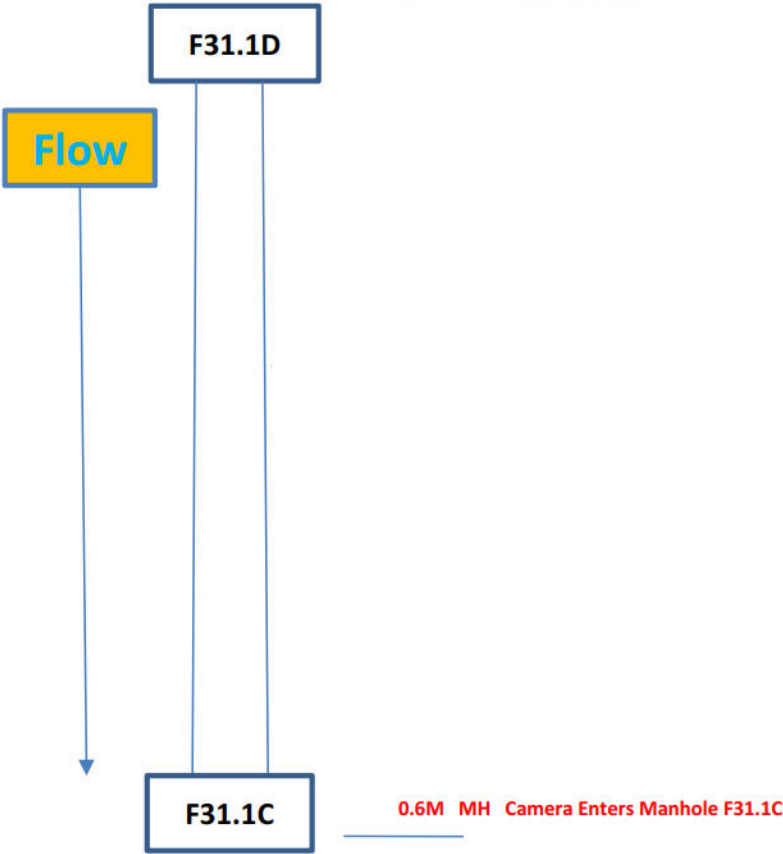
0.0M ST Start Of Survey  
0.0M WL Water Level 0%

REM ; THERE ARE NO DEFECTS WITH THIS SECTION OF PIPE
