Inspection Report

| Site; Tye Lane<br>Place: Warblington | | Division:<br>District: S.W<br>Tape No: 1 | | Start MH: F31.1C<br>End MH: F31.1<br>Total Length: | |

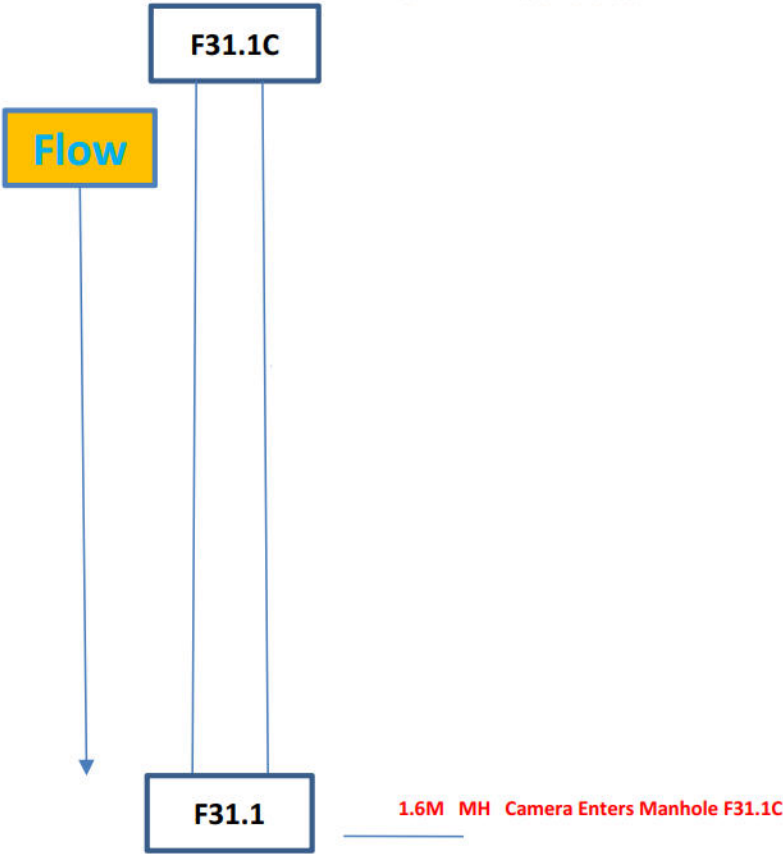
0.0M ST Start Of Survey  
0.0M WL Water Level 0%

REM ; THERE ARE NO DEFECTS WITH THIS SECTION OF PIPE
