Inspection Report

| Site; Tye Lane<br>Place: Warblington | | Division:<br>District: S.W<br>Tape No: 1 | | Start MH: F31.1C<br>End MH: LAT 1<br>Total Length: | |

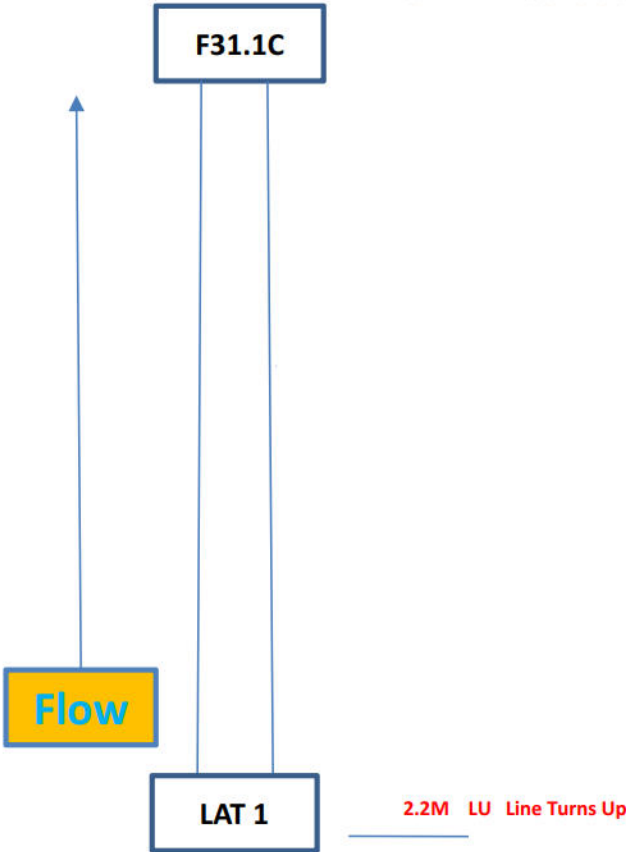
0.0M ST Start Of Survey  
0.0M WL Water Level 0%

REM ; THERE ARE NO DEFECTS WITH THIS SECTION OF PIPE
