Inspection Report

| Site: Tye Lane<br>Place: Warblington | | Division:<br>District: S.W<br>Tape No: 1 | | Start MH: F31.1C<br>End MH: LAT 2<br>Total Length: | |
| Purpose:<br>Use:<br>Catchment: | Structural Defects<br>FOUL<br>P1 Schedule | Size/Shape: Circular dia 100mm<br>Material: PLASTIC<br>Lining:<br>Category: | | | |

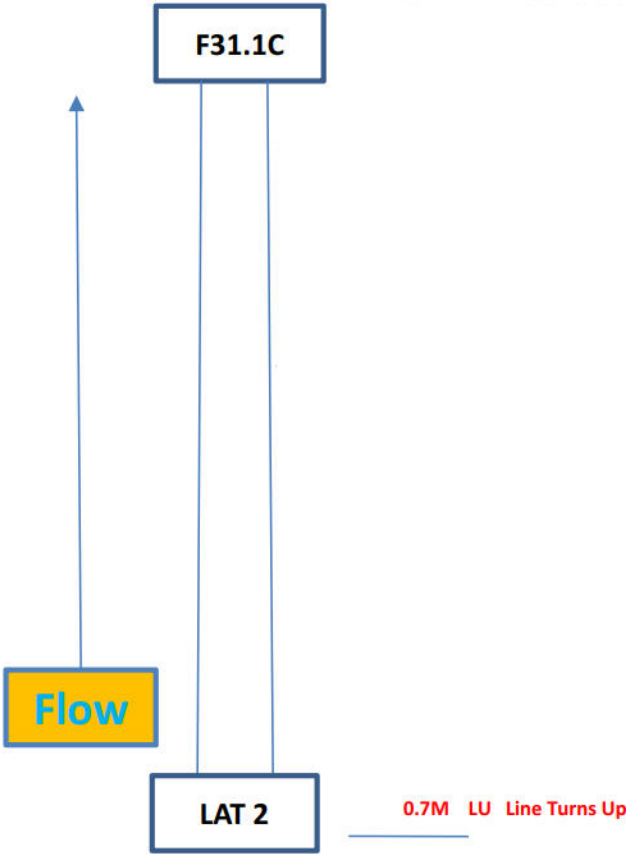
0.0M ST Start Of Survey  
0.0M WL Water Level 0%

REM ; THERE ARE NO DEFECTS WITH THIS SECTION OF PIPE
