Inspection Report

| Site; Tye Lane<br>Place: Warblington | | Division:<br>District: S.W<br>Tape No: 1 | | Start MH: F31.1<br>End MH: LAT 1<br>Total Length: | |

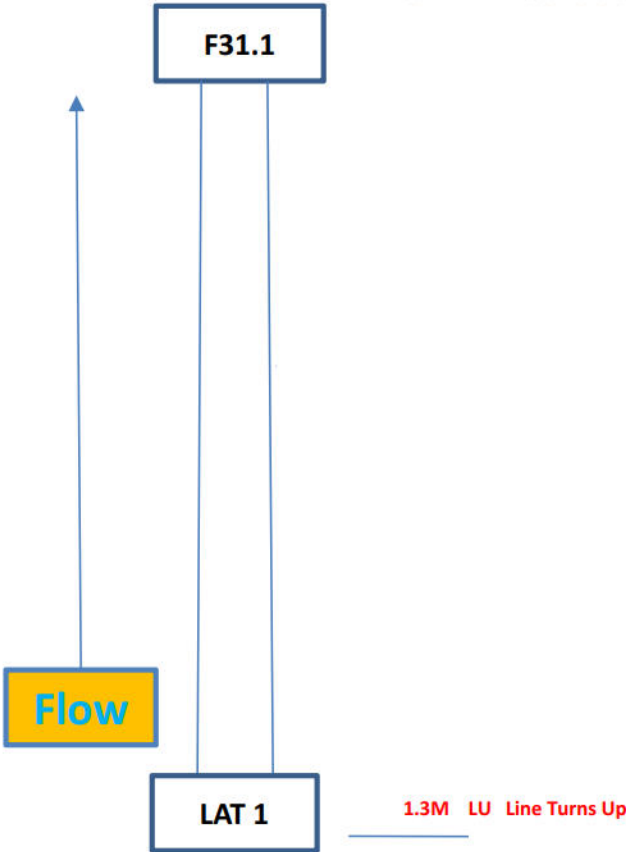
0.0M ST Start Of Survey  
0.0M WL Water Level 0%

REM ; THERE ARE NO DEFECTS WITH THIS SECTION OF PIPE
