Inspection Report

| Site; Tye Lane<br>Place: Warblington | | Division:<br>District: S.W<br>Tape No: 1 | | Start MH: F31.1<br>End MH: LAT 2<br>Total Length: | |
| Purpose:<br>Use:<br>Catchment: | Structural Defects<br>FOUL<br>P1 Schedule | Size/Shape: Circular dia 100mm<br>Material: PLASTIC<br>Lining:<br>Category: | | | |

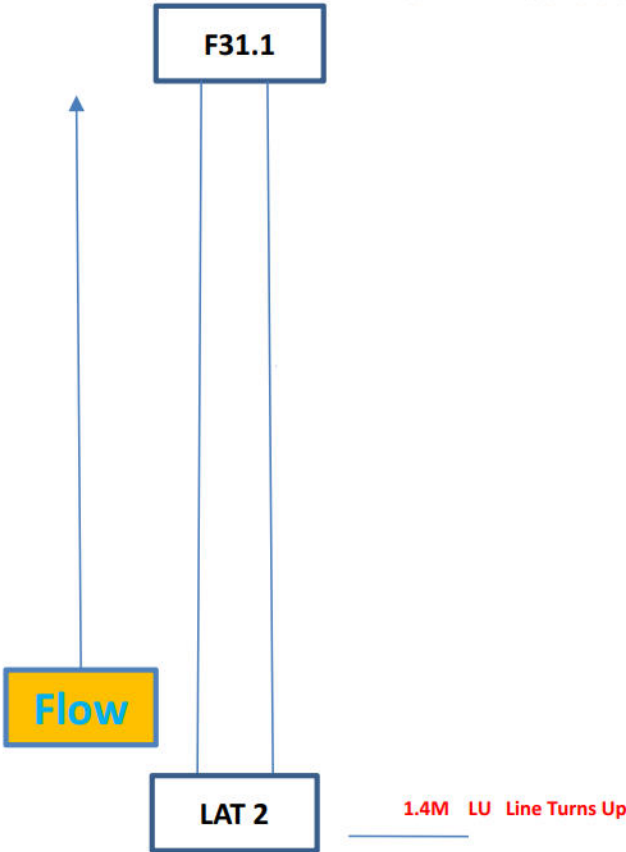
0.0M ST Start Of Survey  
0.0M WL Water Level 0%

REM ; THERE ARE NO DEFECTS WITH THIS SECTION OF PIPE
