Inspection Report

| Site; Tye Lane<br>Place: Warblington | | Division:<br>District: S.W<br>Tape No: 1 | | Start MH: F30.1A<br>End MH: LAT 1<br>Total Length: | |
| Purpose:<br>Use:<br>Catchment: | Structural Defects<br>FOUL<br>P1 Schedule | Size/Shape: Circular dia 100mm<br>Material: PLASTIC<br>Lining:<br>Category: | | | |

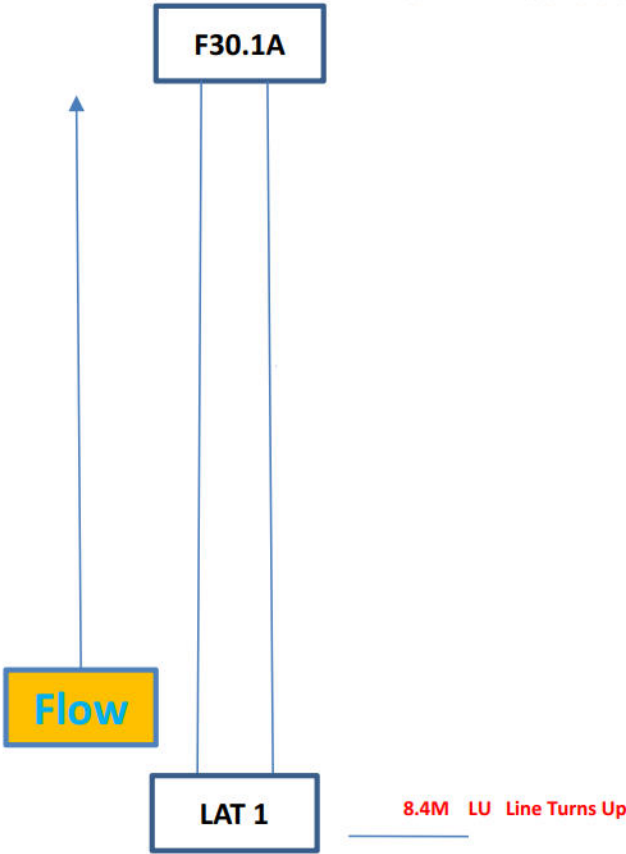
0.0M ST Start Of Survey  
0.0M WL Water Level 0%

REM ; THERE ARE NO DEFECTS WITH THIS SECTION OF PIPE
