Inspection Report

| Site; Tye Lane<br>Place: Warblington | | Division:<br>District: S.W<br>Tape No: 1 | | Start MH: F30.1A<br>End MH: LAT 2<br>Total Length: | |
| Purpose:<br>Use:<br>Catchment: | Structural Defects<br>FOUL<br>P1 Schedule | Size/Shape: Circular dia 100mm<br>Material: PLASTIC<br>Lining:<br>Category: | | | |

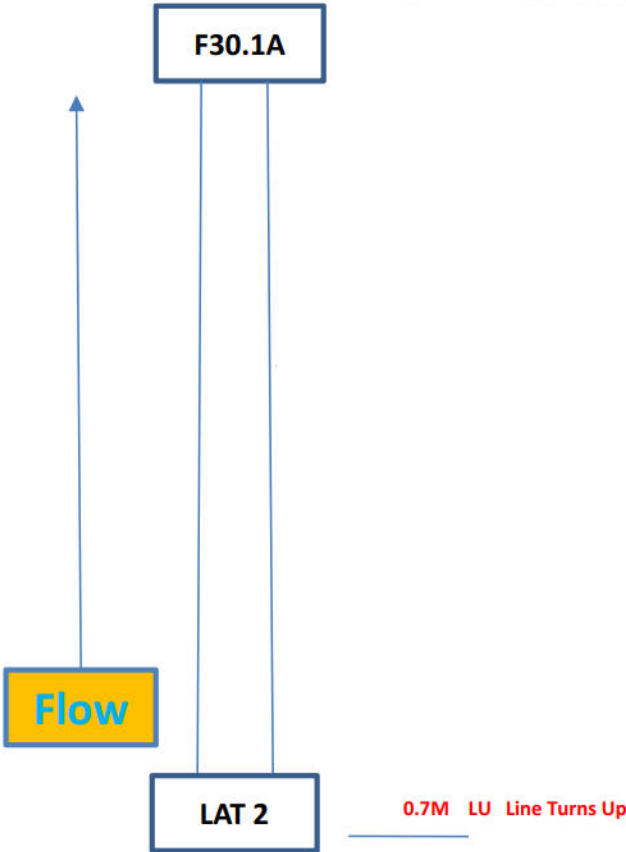
0.0M ST Start Of Survey  
0.0M WL Water Level 0%

REM ; THERE ARE NO DEFECTS WITH THIS SECTION OF PIPE
