Inspection Report

| Site: Tye Lane<br>Place: Warblington | | Division:<br>District: S.W<br>Tape No: 1 | | Start MH: F30.1A<br>End MH: LAT 3<br>Total Length: | |
| Purpose:<br>Use:<br>Catchment: | Structural Defects<br>FOUL<br>P1 Schedule | Size/Shape: Circular dia 100mm<br>Material: PLASTIC<br>Lining:<br>Category: | | | |

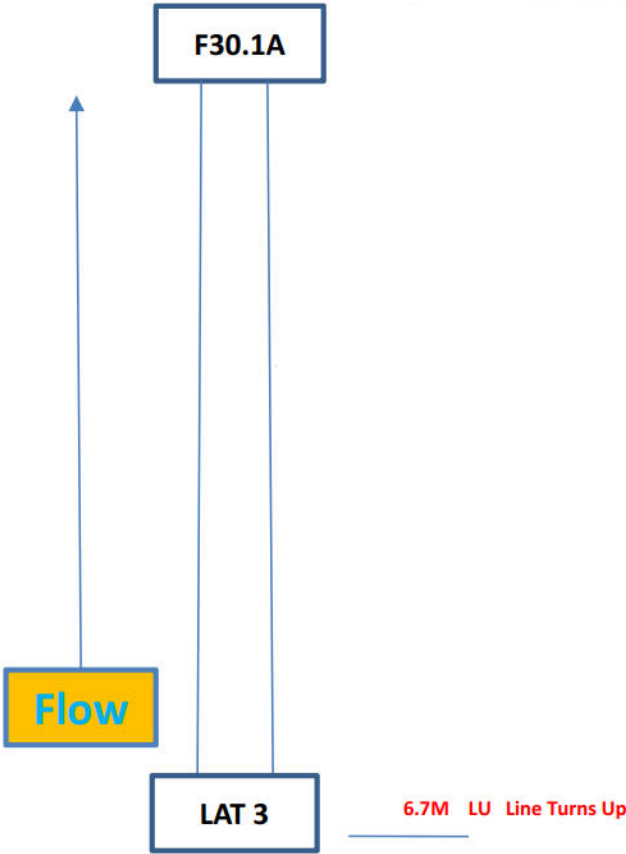
0.0M ST Start Of Survey  
0.0M WL Water Level 0%

REM ; THERE ARE NO DEFECTS WITH THIS SECTION OF PIPE
