Inspection Report

| Site; Tye Lane<br>Place: Warblington | | Division:<br>District: S.W<br>Tape No: 1 | | Start MH: F30.1A<br>End MH: LAT 4<br>Total Length: | |
| Purpose:<br>Use:<br>Catchment: | Structural Defects<br>FOUL<br>P1 Schedule | Size/Shape: Circular dia 100mm<br>Material: PLASTIC<br>Lining:<br>Category: | | | |

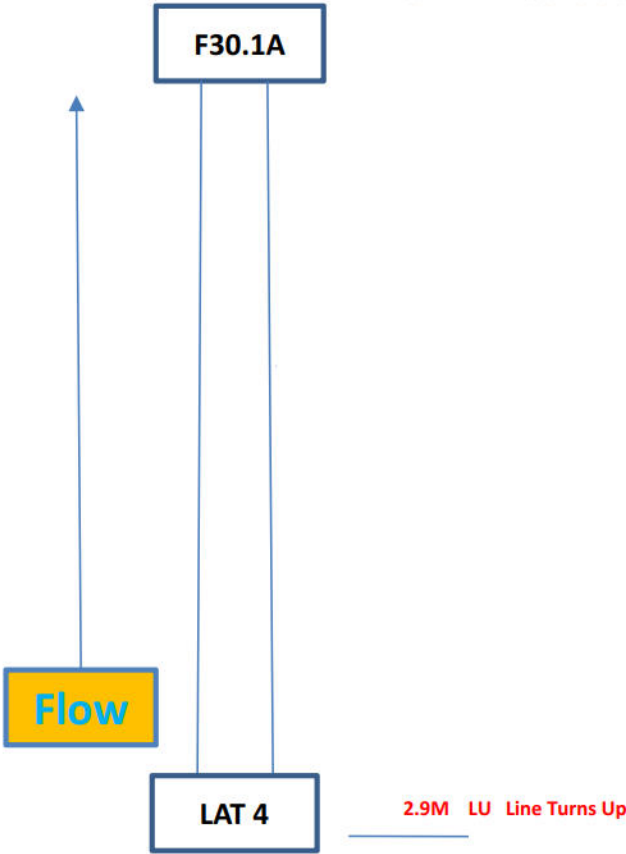
0.0M ST Start Of Survey  
0.0M WL Water Level 0%

REM ; THERE ARE NO DEFECTS WITH THIS SECTION OF PIPE
