Inspection Report

| Site; Tye Lane<br>Place: Warblington | | Division:<br>District: S.W<br>Tape No: 1 | | Start MH: F30.1A<br>End MH: F30.1<br>Total Length: | |

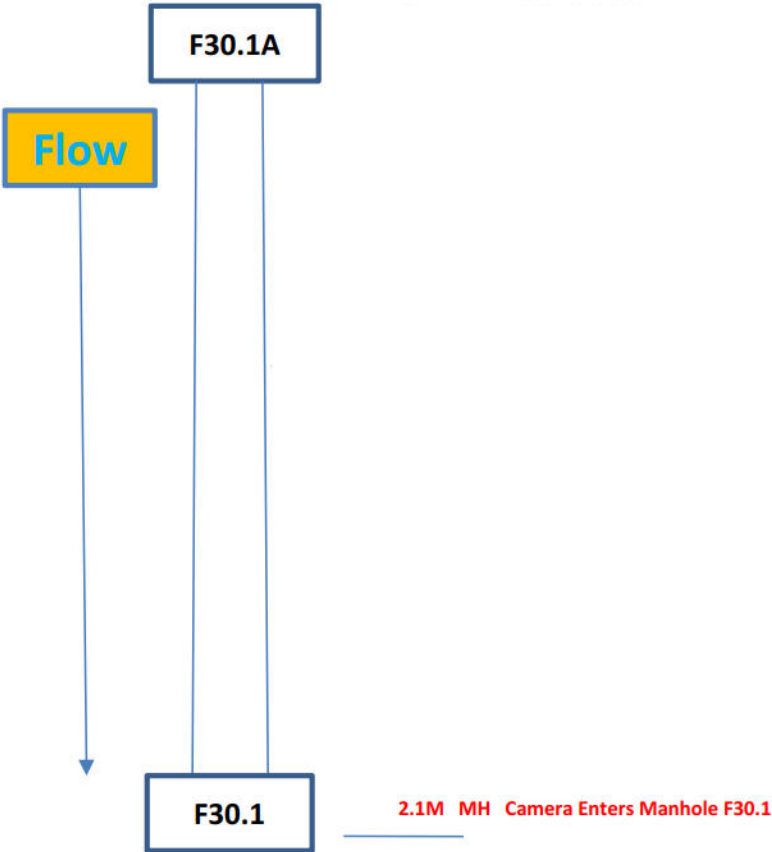
0.0M ST Start Of Survey  
0.0M WL Water Level 0%

REM ; THERE ARE NO DEFECTS WITH THIS SECTION OF PIPE
