Inspection Report

| Site; Tye Lane<br>Place: Warblington | | Division:<br>District: S.W<br>Tape No: 1 | | Start MH: F30.1<br>End MH: MAIN<br>Total Length: | |
| Purpose:<br>Use:<br>Catchment: | Structural Defects<br>FOUL<br>P1 Schedule | Size/Shape: Circular dia 100mm<br>Material: PLASTIC<br>Lining:<br>Category: | | | |

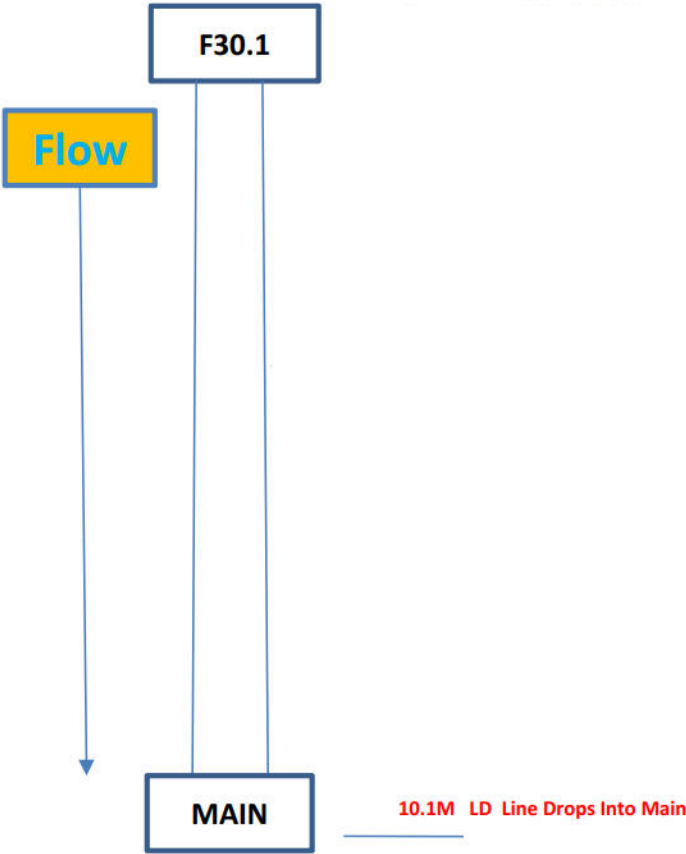
0.0M ST Start Of Survey  
0.0M WL Water Level 0%

REM ; THERE ARE NO DEFECTS WITH THIS SECTION OF PIPE
