Inspection Report

| Site; Tye Lane<br>Place: Warblington | | Division:<br>District: S.W<br>Tape No: 1 | | Start MH: F31.2A<br>End MH: LAT 1<br>Total Length: | |

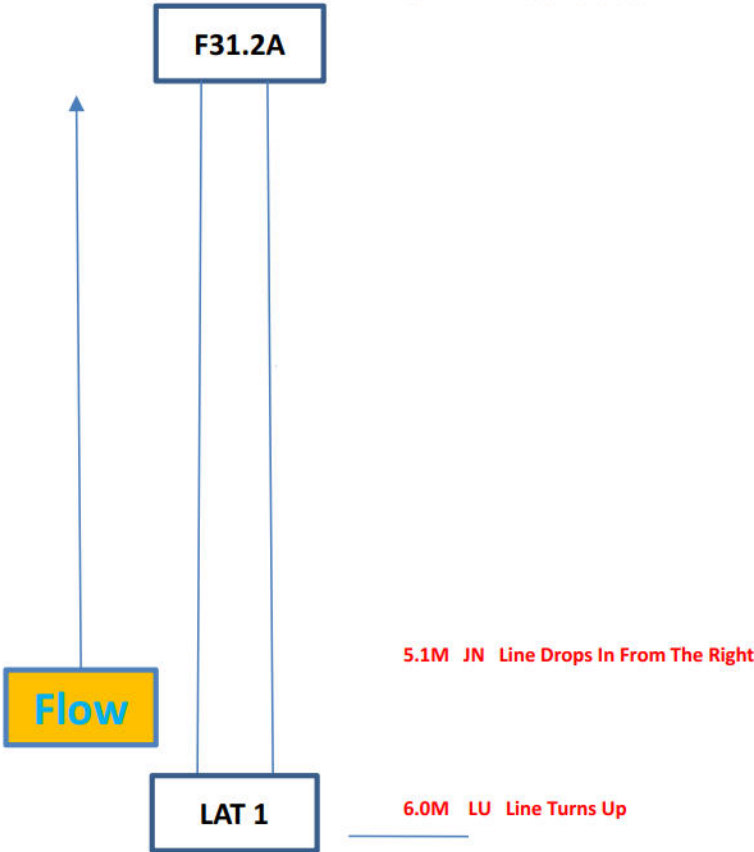
0.0M ST Start Of Survey  
0.0M WL Water Level 0%

REM ; THERE ARE NO DEFECTS WITH THIS SECTION OF PIPE
