Inspection Report

| Site; Tye Lane<br>Place: Warblington | | Division:<br>District: S.W<br>Tape No: 1 | | Start MH: F30.1B<br>End MH: LAT 1<br>Total Length: | |

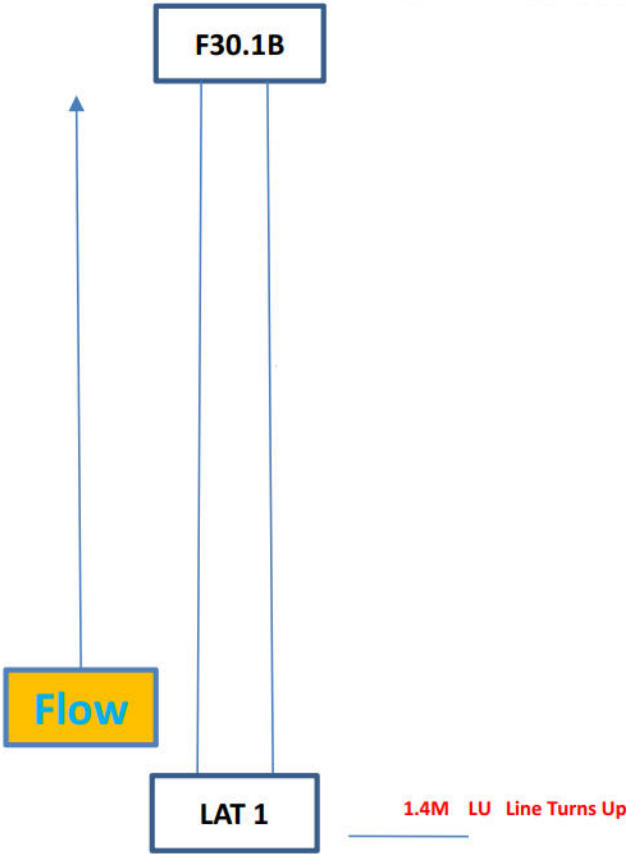
0.0M ST Start Of Survey  
0.0M WL Water Level 0%

REM ; THERE ARE NO DEFECTS WITH THIS SECTION OF PIPE
