Inspection Report

| Site; Tye Lane<br>Place: Warblington | | Division:<br>District: S.W<br>Tape No: 1 | | Start MH: F30.1B<br>End MH: LAT 2<br>Total Length: | |

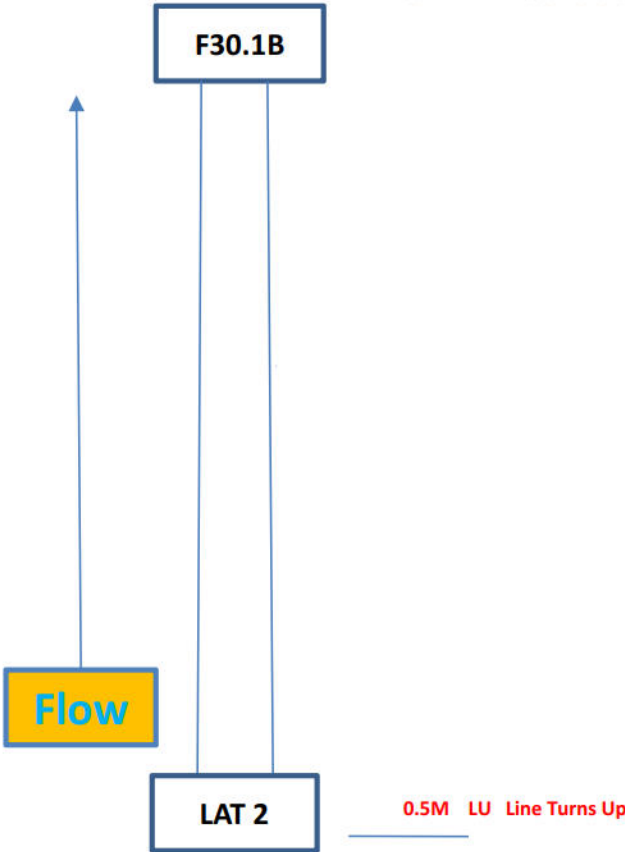
0.0M ST Start Of Survey  
0.0M WL Water Level 0%

REM ; THERE ARE NO DEFECTS WITH THIS SECTION OF PIPE
