Inspection Report

| Site; Tye Lane<br>Place: Warblington | | Division:<br>District: S.W<br>Tape No: 1 | | Start MH: F30.1B<br>End MH: LAT 3<br>Total Length: | |
| Purpose:<br>Use:<br>Catchment: | Structural Defects<br>FOUL<br>P1 Schedule | Size/Shape: Circular dia 100mm<br>Material: PLASTIC<br>Lining:<br>Category: | | | |

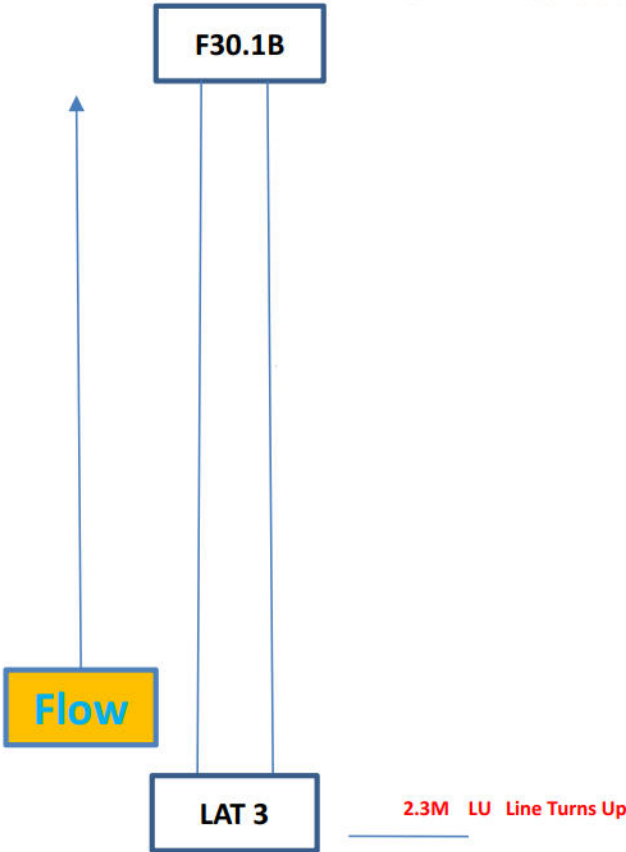
0.0M ST Start Of Survey  
0.0M WL Water Level 0%

REM ; THERE ARE NO DEFECTS WITH THIS SECTION OF PIPE
