Inspection Report

| Site; Tye Lane<br>Place: Warblington | | Division:<br>District: S.W<br>Tape No: 1 | | Start MH: F30.1B<br>End MH: MAIN<br>Total Length: | |

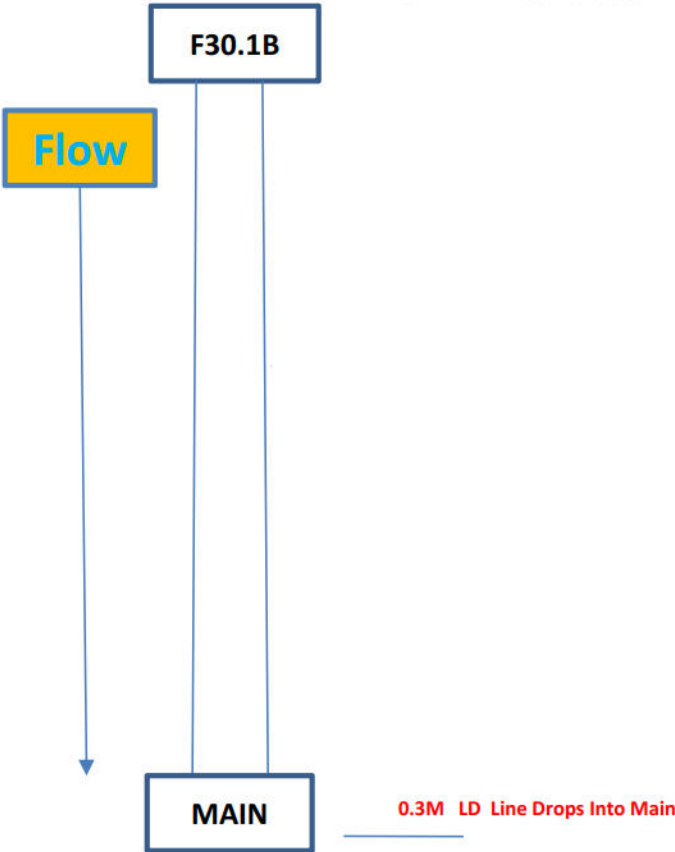
0.0M ST Start Of Survey  
0.0M WL Water Level 0%

REM ; THERE ARE NO DEFECTS WITH THIS SECTION OF PIPE
