Inspection Report

| Site; Tye Lane<br>Place: Warblington | | Division:<br>District: S.W<br>Tape No: 1 | | Start MH: F29.1A<br>End MH: LAT 1<br>Total Length: | |
| Purpose:<br>Use:<br>Catchment: | Structural Defects<br>FOUL<br>P1 Schedule | Size/Shape: Circular dia 100mm<br>Material: PLASTIC<br>Lining:<br>Category: | | | |

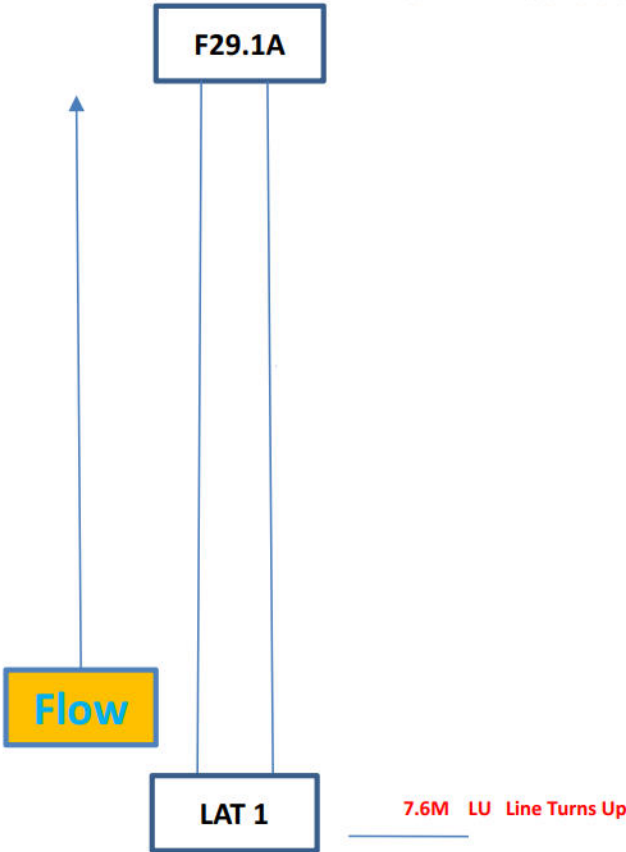
0.0M ST Start Of Survey  
0.0M WL Water Level 0%

REM ; THERE ARE NO DEFECTS WITH THIS SECTION OF PIPE
