Inspection Report

| Site; Tye Lane<br>Place: Warblington | | Division:<br>District: S.W<br>Tape No: 1 | | Start MH: F29.1A<br>End MH: LAT 2<br>Total Length: | |
| Purpose:<br>Use:<br>Catchment: | Structural Defects<br>FOUL<br>P1 Schedule | Size/Shape: Circular dia 100mm<br>Material: PLASTIC<br>Lining:<br>Category: | | | |

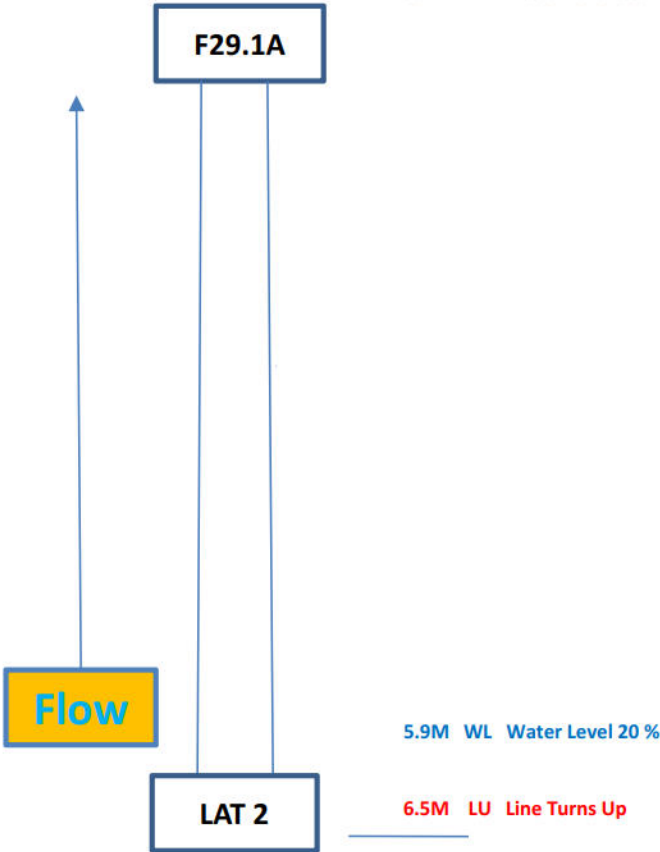
REM ; THERE IS AN UNDERROLL IN THIS SECTION OF PIPE
