Inspection Report

| Site; Tye Lane<br>Place: Warblington | | Division:<br>District: S.W<br>Tape No: 1 | | Start MH: F29.1A<br>End MH: F29.1B<br>Total Length: | |
| Purpose:<br>Use:<br>Catchment: | Structural Defects<br>FOUL<br>P1 Schedule | Size/Shape: Circular dia 100mm<br>Material: PLASTIC<br>Lining:<br>Category: | | | |

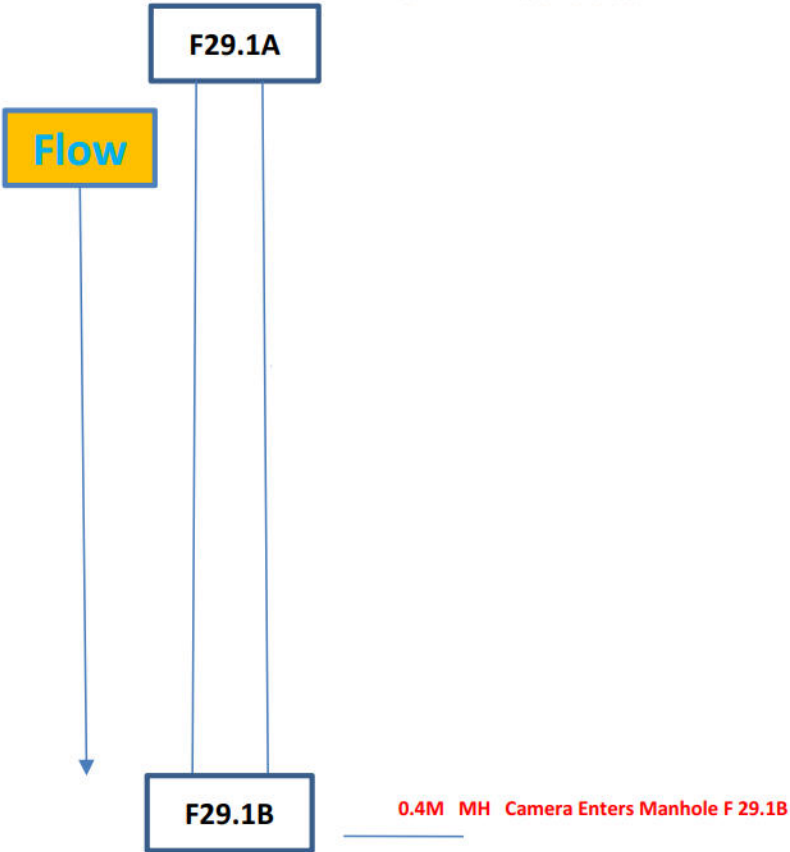
0.0M ST Start Of Survey  
0.0M WL Water Level 0%

REM ; THERE ARE NO DEFECTS WITH THIS SECTION OF PIPE
