Inspection Report

| Site; Tye Lane<br>Place: Warblington | | Division:<br>District: S.W<br>Tape No: 1 | | Start MH: F29.1B<br>End MH: F29.1<br>Total Length: | |

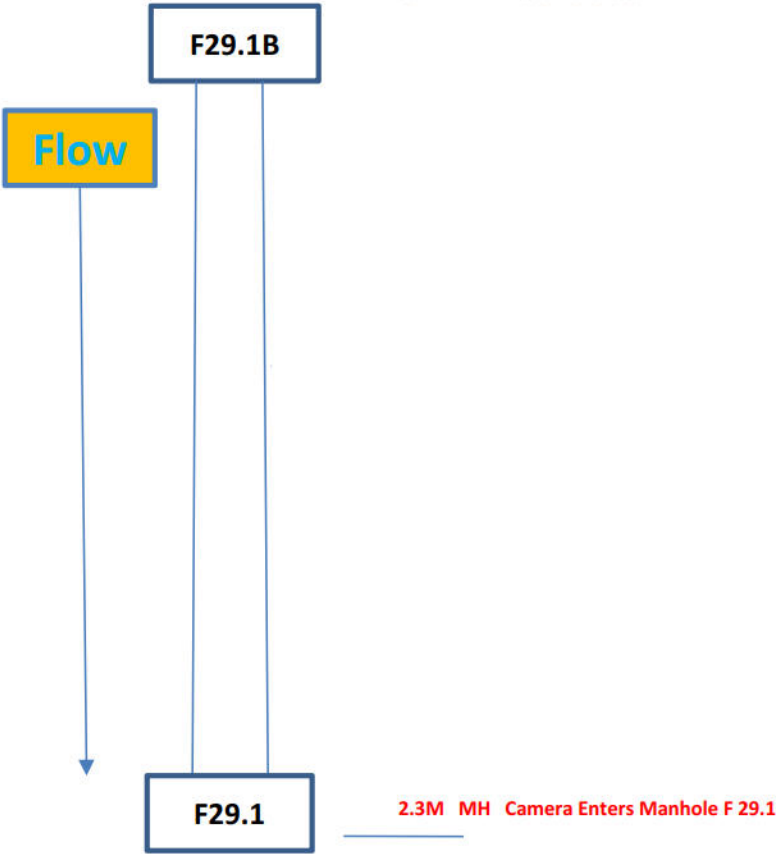
REM ; THERE ARE NO DEFECTS WITH THIS SECTION OF PIPE
