Inspection Report

| Site; Tye Lane<br>Place: Warblington | | Division:<br>District: S.W<br>Tape No: 1 | | Start MH: F29.1B<br>End MH: LAT 1<br>Total Length: | |
| Purpose:<br>Use:<br>Catchment: | Structural Defects<br>FOUL<br>P1 Schedule | Size/Shape: Circular dia 100mm<br>Material: PLASTIC<br>Lining:<br>Category: | | | |

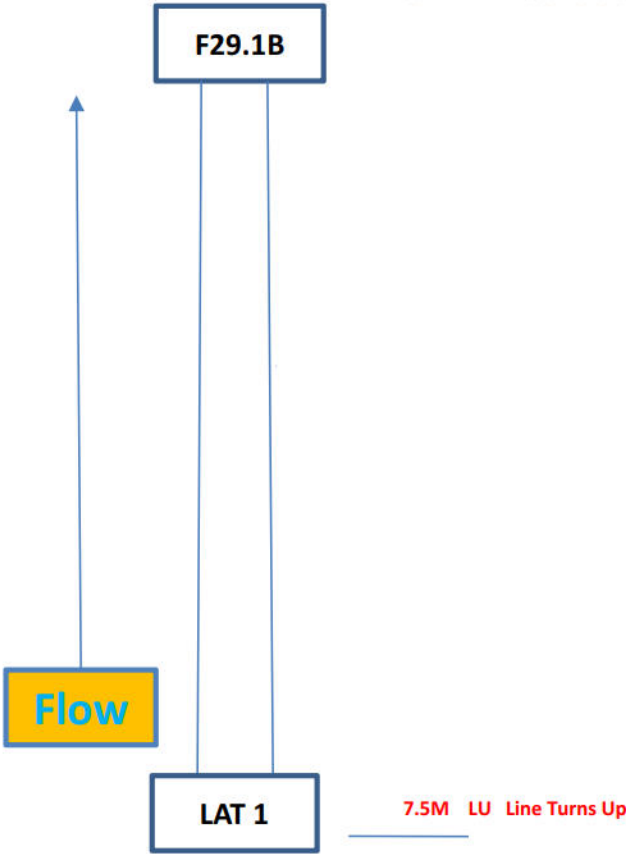
0.0M ST Start Of Survey  
0.0M WL Water Level 0%

REM ; THERE ARE NO DEFECTS IN THIS SECTION OF PIPE
