Inspection Report

| Site; Tye Lane<br>Place: Warblington | | Division:<br>District: S.W<br>Tape No: 1 | | Start MH: F29.1B<br>End MH: LAT 2<br>Total Length: | |

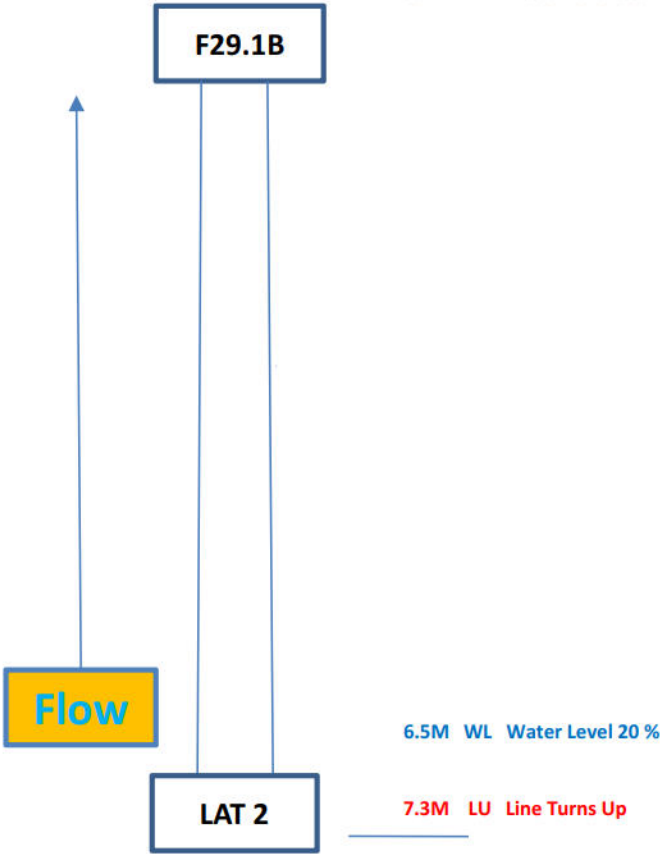
REM ; THERE IS AN UNDERROLL IN THIS SECTION OF PIPE
