Inspection Report

| Site; Tye Lane<br>Place: Warblington | | Division:<br>District: S.W<br>Tape No: 1 | | Start MH: F31.2A<br>End MH: LAT 2<br>Total Length: | |
| Purpose:<br>Use:<br>Catchment: | Structural Defects<br>FOUL<br>P1 Schedule | Size/Shape: Circular dia 100mm<br>Material: PLASTIC<br>Lining:<br>Category: | | | |

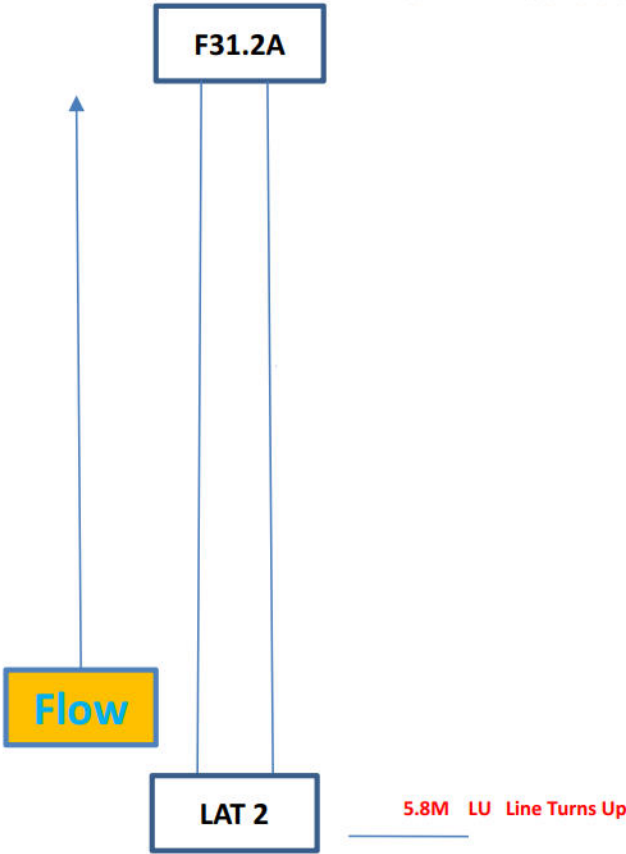
0.0M ST Start Of Survey  
0.0M WL Water Level 0%

REM ; THERE ARE NO DEFECTS WITH THIS SECTION OF PIPE
