Inspection Report

| Site; Tye Lane<br>Place: Warblington | | Division:<br>District: S.W<br>Tape No: 1 | | Start MH: F29.1<br>End MH: LAT 1<br>Total Length: | |
| Purpose:<br>Use:<br>Catchment: | Structural Defects<br>FOUL<br>P1 Schedule | Size/Shape: Circular dia 100mm<br>Material: PLASTIC<br>Lining:<br>Category: | | | |

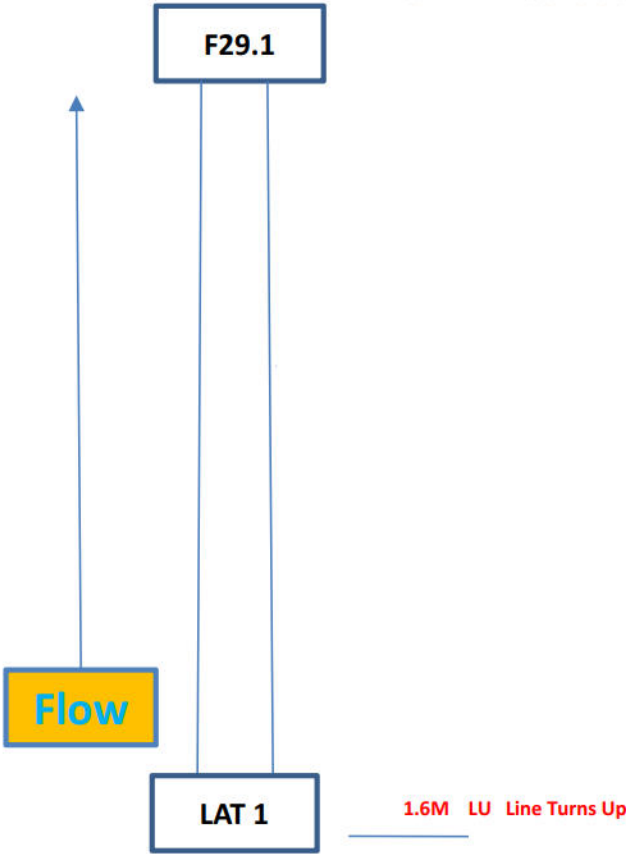
0.0M ST Start Of Survey  
0.0M WL Water Level 0%

REM ; THERE ARE NO DEFECTS IN THIS SECTION OF PIPE
