Inspection Report

| Site; Tye Lane<br>Place: Warblington | | Division:<br>District: S.W<br>Tape No: 1 | | Start MH: F29.1<br>End MH: MAIN<br>Total Length: | |

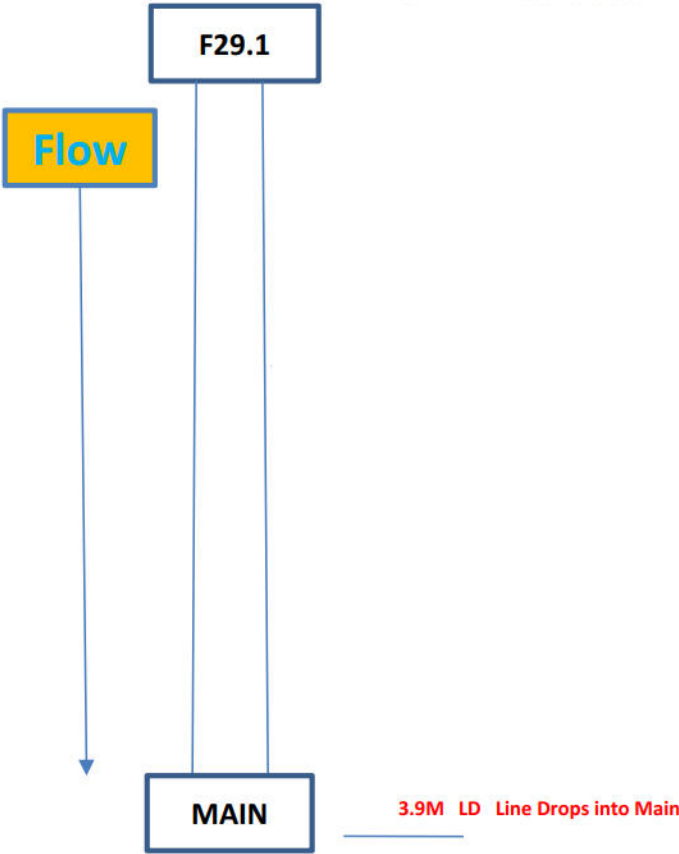
0.0M ST Start Of Survey  
0.0M WL Water Level 0%

REM ; THERE ARE NO DEFECTS WITH THIS SECTION OF PIPE
