Inspection Report

| Site; Tye Lane<br>Place: Warblington | | Division:<br>District: S.W<br>Tape No: 1 | | Start MH: F31<br>End MH: F31.1<br>Total Length: | |
| Purpose:<br>Use:<br>Catchment: | Structural Defects<br>FOUL<br>P1 Schedule | Size/Shape: Circular dia 150mm<br>Material: PLASTIC<br>Lining:<br>Category: | | | |

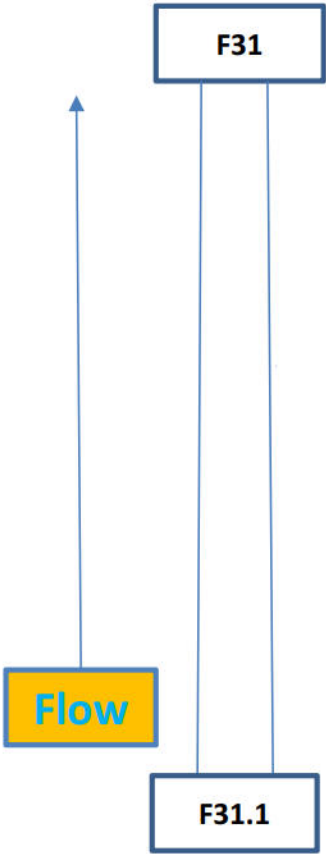
0.0M ST Start Of Survey  
0.0M WL Water Level 0%

1.0M PR Pipe Reduces To 100mm

REM ; THERE ARE NO DEFECTS IN THIS SECTION OF PIPE
