Inspection Report

| Site; Tye Lane<br>Place: Warblington | | Division:<br>District: S.W<br>Tape No: 1 | | Start MH: F31<br>End MH: F32<br>Total Length: | |
| Purpose:<br>Use:<br>Catchment: | Structural Defects<br>FOUL<br>P1 Schedule | Size/Shape: Circular dia 150mm<br>Material: PLASTIC<br>Lining:<br>Category: | | | |

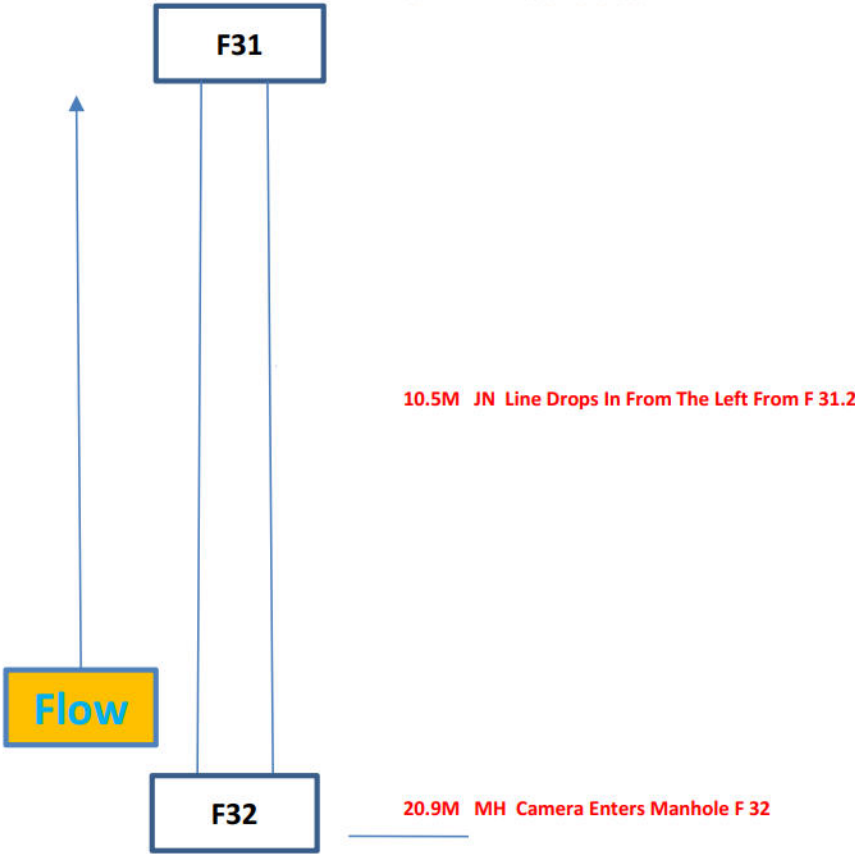
0.0M ST Start Of Survey  
0.0M WL Water Level 0%

REM ; THERE ARE NO DEFECTS IN THIS SECTION OF PIPE
