Inspection Report

| Site; Tye Lane<br>Place: Warblington | | Division:<br>District: S.W<br>Tape No: 1 | | Start MH: F31<br>End MH: F30<br>Total Length: | |
| Purpose:<br>Use:<br>Catchment: | Structural Defects<br>FOUL<br>P1 Schedule | Size/Shape: Circular dia 150mm<br>Material: PLASTIC<br>Lining:<br>Category: | | | |

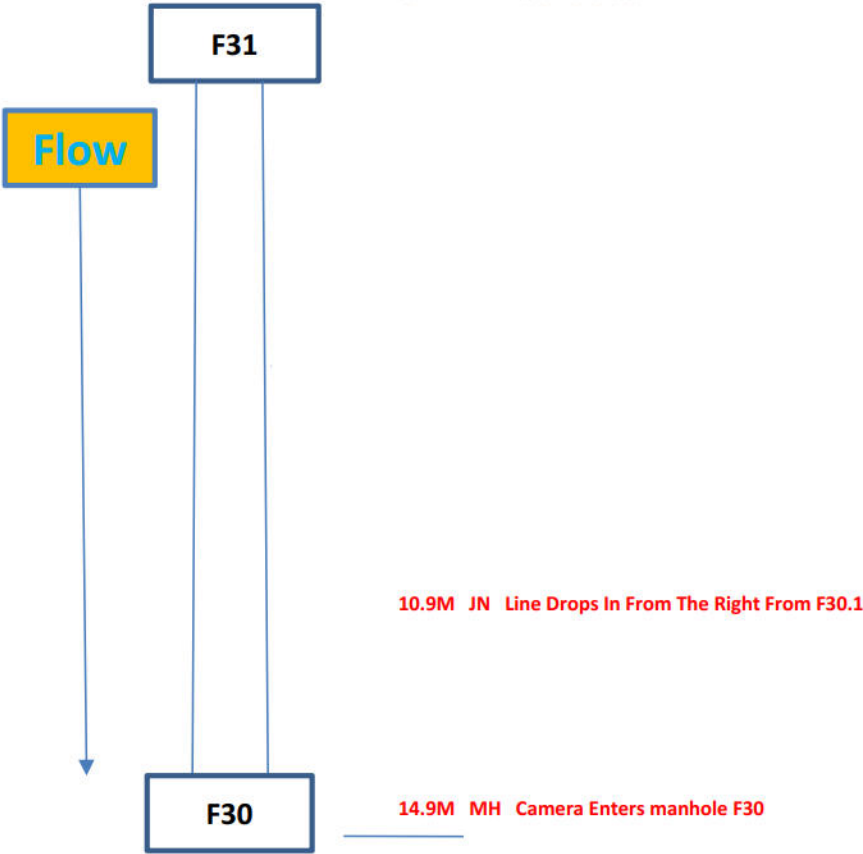
0.0M ST Start Of Survey  
0.0M WL Water Level 0%

REM ; THERE ARE NO DEFECTS WITH THIS SECTION OF PIPE
