Inspection Report

| Site; Tye Lane<br>Place: Warblington | | Division:<br>District: S.W<br>Tape No: 1 | | Start MH: F30<br>End MH: F43<br>Total Length: | |

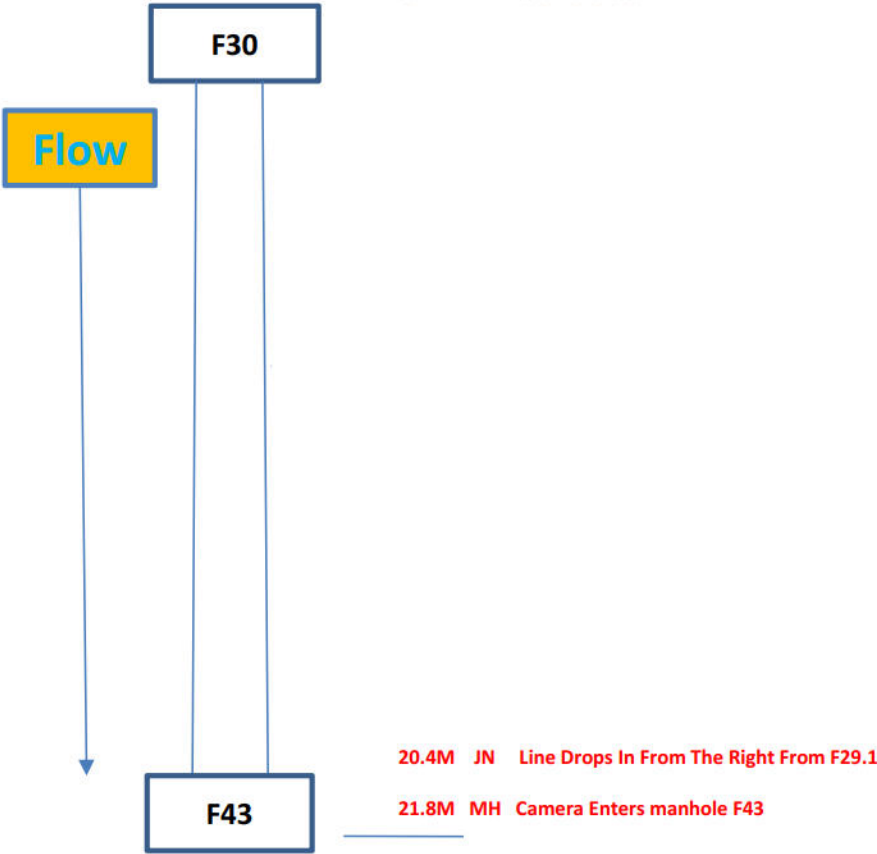
0.0M ST Start Of Survey  
0.0M WL Water Level 0%

REM ; THERE ARE NO DEFECTS WITH THIS SECTION OF PIPE
