Inspection Report

| Site; Tye Lane<br>Place: Warblington | | Division:<br>District: S.W<br>Tape No: 1 | | Start MH: S14.2<br>End MH: LAT 1<br>Total Length: | |
| Purpose:<br>Use:<br>Catchment: | Structural Defects<br>STORM<br>P1 Schedule | Size/Shape: Circular dia 100mm<br>Material: PLASTIC<br>Lining:<br>Category: | | | |

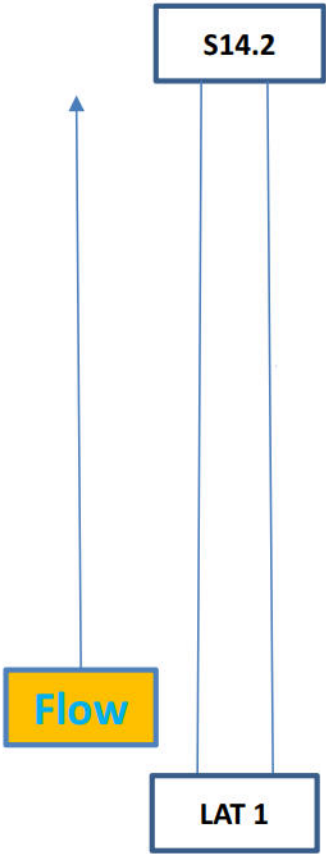
0.0M ST Start Of Survey  
0.0M WL Water Level 0%  
0.1M JN Line Drops In From The Left

10.2M JN Line Drops in From The Left  
10.9M RE Camera Stops AAt Rodding Eye

REM ; THERE ARE NO DEFECTS IN THIS SECTION OF PIPE
