Inspection Report

| Site; Tye Lane<br>Place: Warblington | | Division:<br>District: S.W<br>Tape No: 1 | | Start MH: S14.2<br>End MH: MAIN<br>Total Length: | |

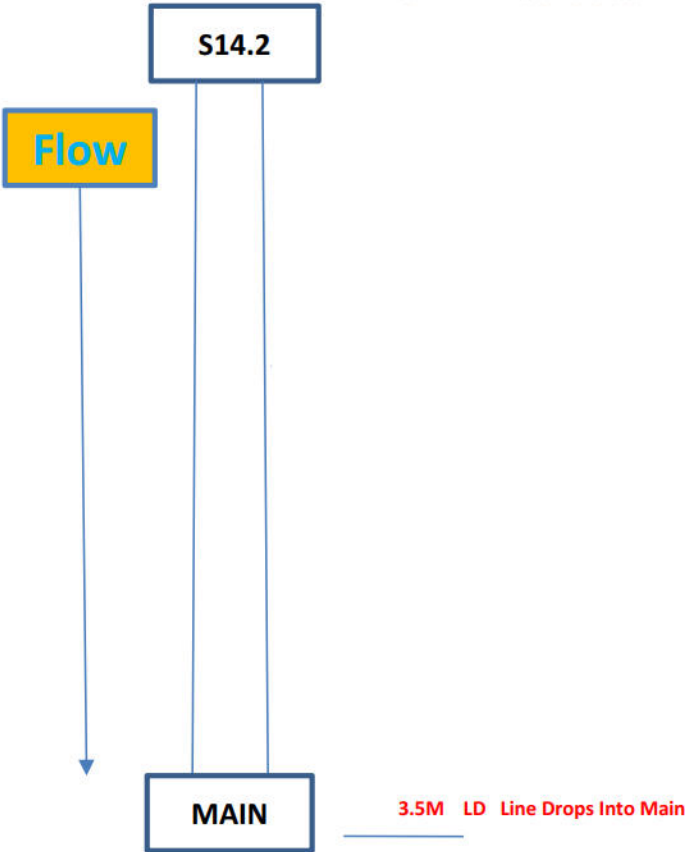
0.0M ST Start Of Survey  
0.0M WL Water Level 0%

REM ; THERE ARE NO DEFECTS WITH THIS SECTION OF PIPE
