Inspection Report

| Site; Tye Lane<br>Place: Warblington | | Division:<br>District: S.W<br>Tape No: 1 | | Start MH: S14.1<br>End MH: MAIN<br>Total Length: | |
| Purpose:<br>Use:<br>Catchment: | Structural Defects<br>STORM<br>P1 Schedule | Size/Shape: Circular dia 100mm<br>Material: PLASTIC<br>Lining:<br>Category: | | | |

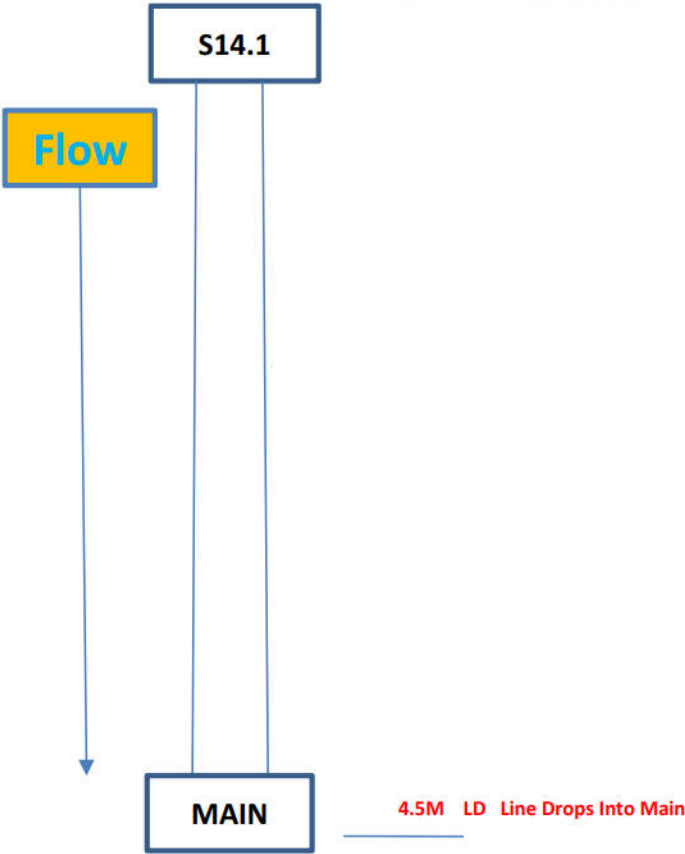
0.0M ST Start Of Survey  
0.0M WL Water Level 0%

REM ; THERE ARE NO DEFECTS WITH THIS SECTION OF PIPE
