Inspection Report

| Site; Tye Lane<br>Place: Warblington | | Division:<br>District: S.W<br>Tape No: 1 | | Start MH: S14.1<br>End MH: LAT 1<br>Total Length: | |
| Purpose:<br>Use:<br>Catchment: | Structural Defects<br>STORM<br>P1 Schedule | Size/Shape: Circular dia 100mm<br>Material: PLASTIC<br>Lining:<br>Category: | | | |

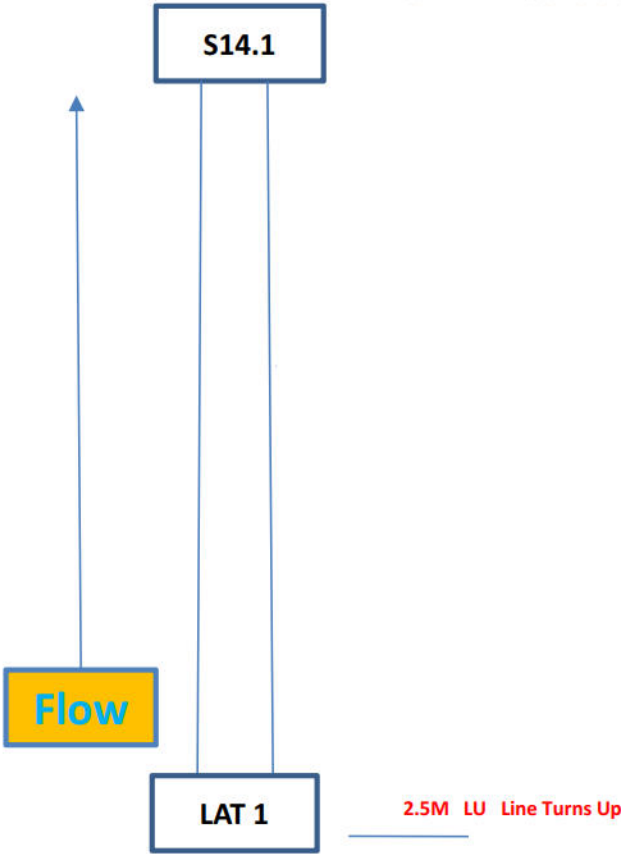
0.0M ST Start Of Survey  
0.0M WL Water Level 0%

REM ; THERE ARE NO DEFECTS IN THIS SECTION OF PIPE
