Inspection Report

| Site; Tye Lane<br>Place: Warblington | | Division:<br>District: S.W<br>Tape No: 1 | | Start MH: F31.2A<br>End MH: F31.2B<br>Total Length: | |

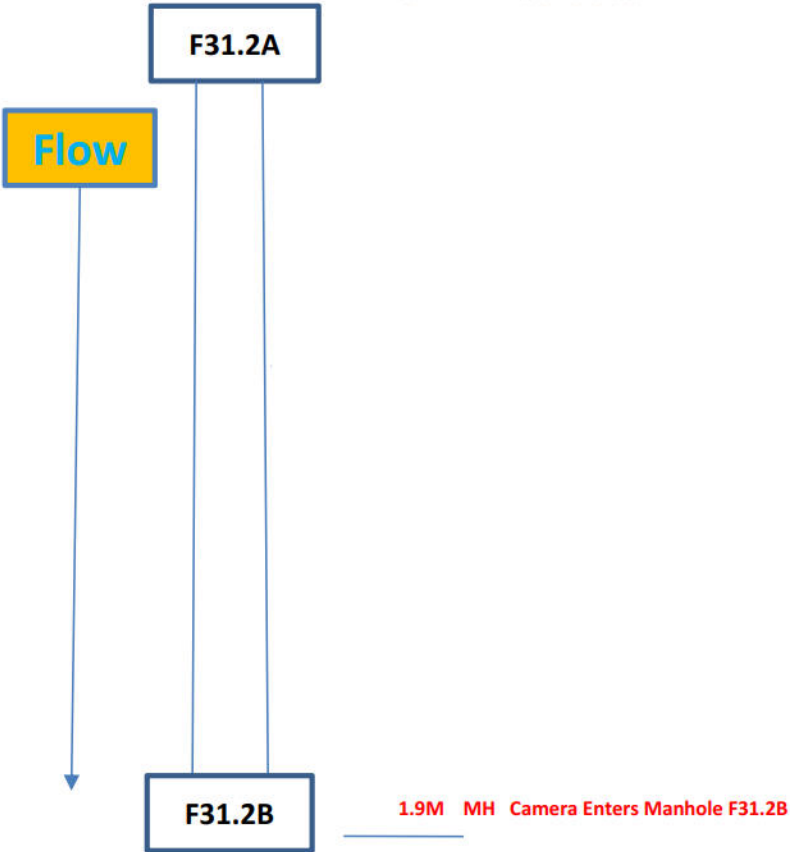
0.0M ST Start Of Survey  
0.0M WL Water Level 0%

REM ; THERE ARE NO DEFECTS WITH THIS SECTION OF PIPE
