Inspection Report

| Site: Tye Lane<br>Place: Warblington | | Division:<br>District: S.W<br>Tape No: 1 | | Start MH: S14.1<br>End MH: LAT 2<br>Total Length: | |
| Purpose:<br>Use:<br>Catchment: | Structural Defects<br>STORM<br>P1 Schedule | Size/Shape: Circular dia 100mm<br>Material: PLASTIC<br>Lining:<br>Category: | | | |

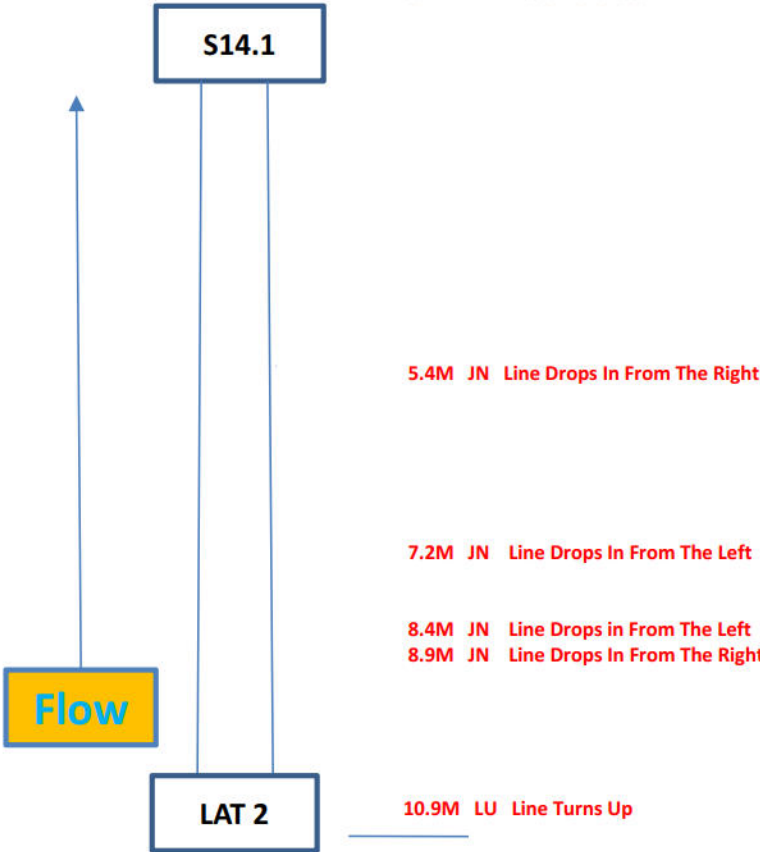
0.0M ST Start Of Survey  
0.0M WL Water Level 0%

REM ; THERE ARE NO DEFECTS IN THIS SECTION OF PIPE
