Inspection Report

| Site; Tye Lane<br>Place: Warblington | | Division:<br>District: S.W<br>Tape No: 1 | | Start MH: S14.1<br>End MH: LAT 3<br>Total Length: | |
| Purpose:<br>Use:<br>Catchment: | Structural Defects<br>STORM<br>P1 Schedule | Size/Shape: Circular dia 100mm<br>Material: PLASTIC<br>Lining:<br>Category: | | | |

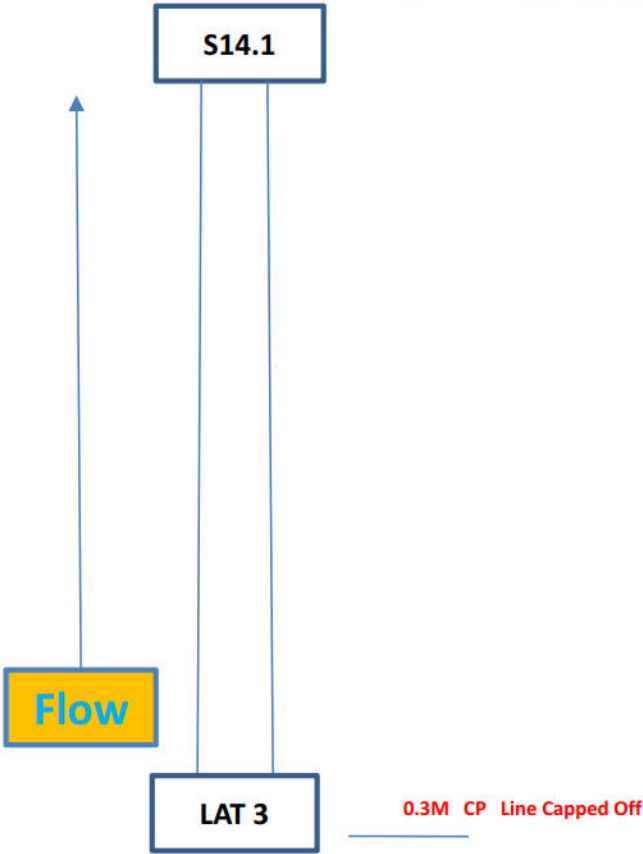
0.0M ST Start Of Survey  
0.0M WL Water Level 0%

REM ; THERE ARE NO DEFECTS IN THIS SECTION OF PIPE BUT IT IS CAPPED OFF
