Inspection Report

| Site; Tye Lane<br>Place: Warblington | | Division:<br>District: S.W<br>Tape No: 1 | | Start MH: S14.1<br>End MH: LAT 4<br>Total Length: | |

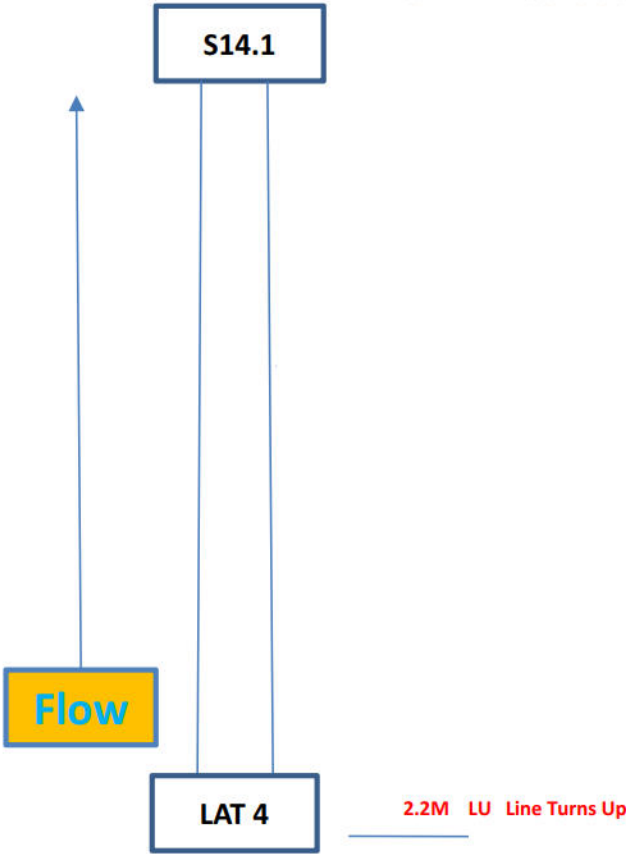
0.0M ST Start Of Survey  
0.0M WL Water Level 0%

REM ; THERE ARE NO DEFECTS IN THIS SECTION OF PIPE
