Inspection Report

| Site; Tye Lane<br>Place: Warblington | | Division:<br>District: S.W<br>Tape No: 1 | | Start MH: S13.2<br>End MH: LAT 1<br>Total Length: | |
| Purpose:<br>Use:<br>Catchment: | Structural Defects<br>STORM<br>P1 Schedule | Size/Shape: Circular dia 100mm<br>Material: PLASTIC<br>Lining:<br>Category: | | | |

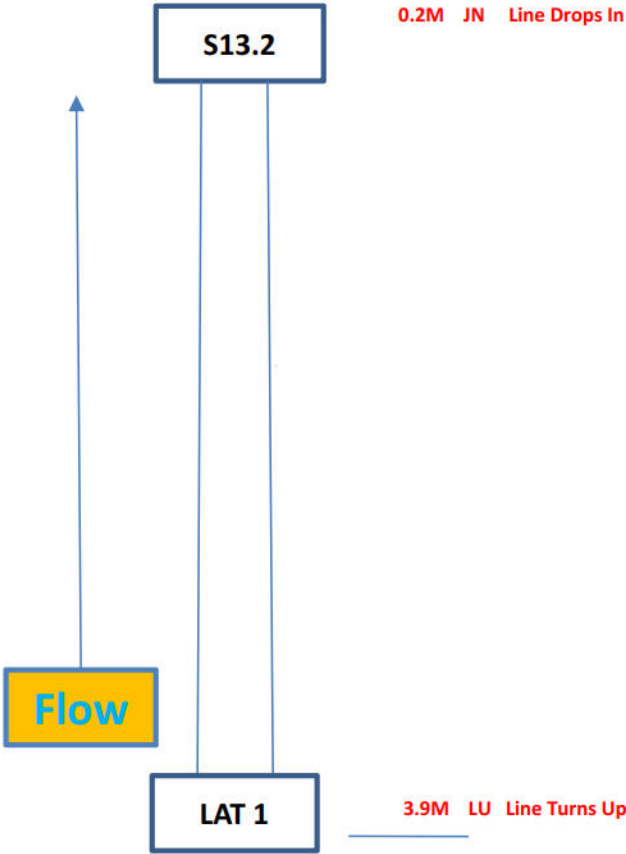
0.0M ST Start Of Survey  
0.0M WL Water Level 0%  
0.2M JN Line Drops In From The Left

REM ; THERE ARE NO DEFECTS IN THIS SECTION OF PIPE
