Inspection Report

| Site; Tye Lane<br>Place: Warblington | | Division:<br>District: S.W<br>Tape No: 1 | | Start MH: S13.2<br>End MH: LAT 2<br>Total Length: | |

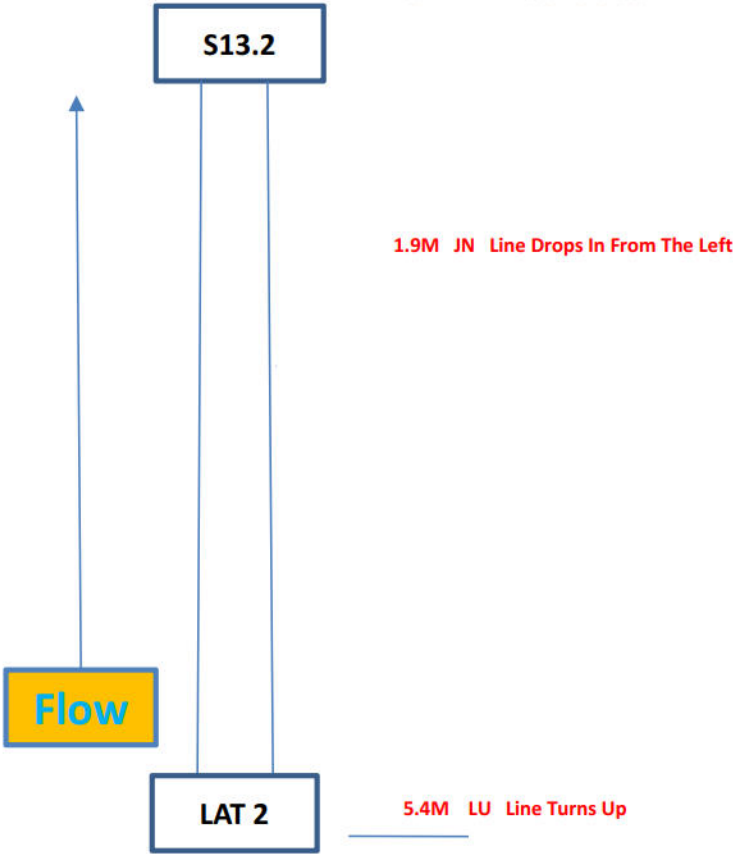
0.0M ST Start Of Survey  
0.0M WL Water Level 0%

REM ; THERE ARE NO DEFECTS IN THIS SECTION OF PIPE
