Inspection Report

| Site; Tye Lane<br>Place: Warblington | | Division:<br>District: S.W<br>Tape No: 1 | | Start MH: \$13.1<br>End MH: MAIN<br>Total Length: | |
| Purpose:<br>Use:<br>Catchment: | Structural Defects<br>STORM<br>P1 Schedule | Size/Shape: Circular dia 100mm<br>Material: PLASTIC<br>Lining:<br>Category: | | | |

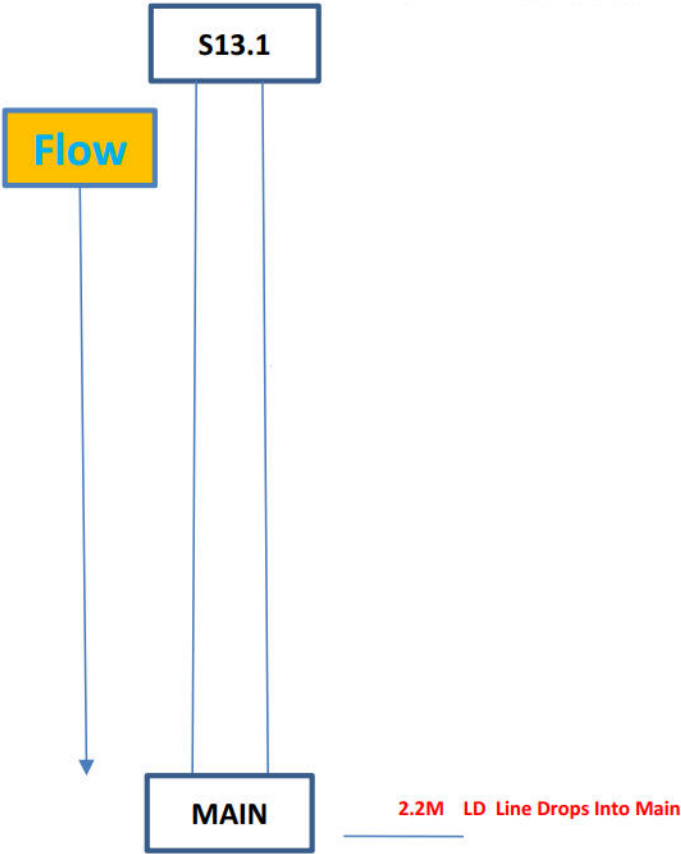
0.0M ST Start Of Survey  
0.0M WL Water Level 0%

REM ; THERE ARE NO DEFECTS WITH THIS SECTION OF PIPE
