Inspection Report

| Site; Tye Lane<br>Place: Warblington | | Division:<br>District: S.W<br>Tape No: 1 | | Start MH: \$13.1<br>End MH: LAT 1<br>Total Length: | |
| Purpose:<br>Use:<br>Catchment: | Structural Defects<br>STORM<br>P1 Schedule | Size/Shape: Circular dia 100mm<br>Material: PLASTIC<br>Lining:<br>Category: | | | |

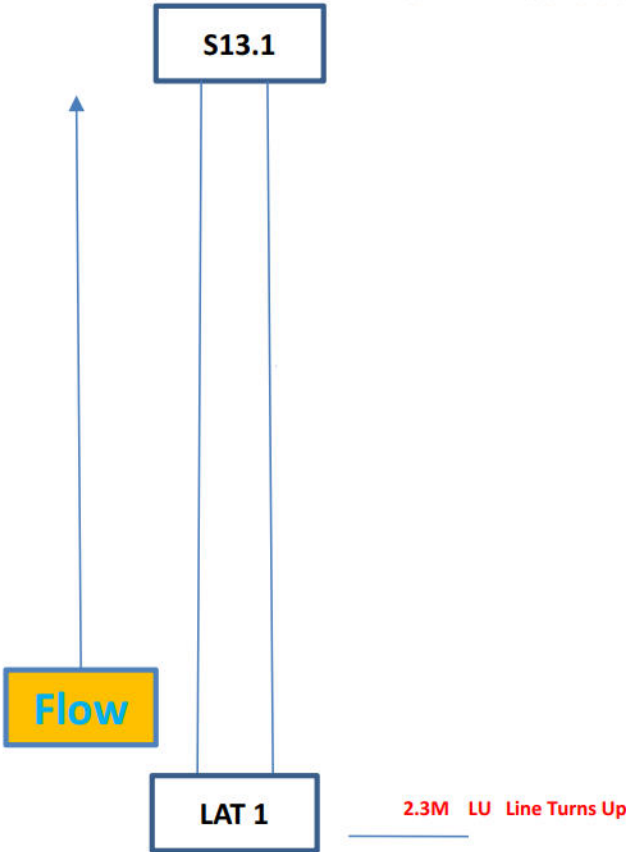
0.0M ST Start Of Survey  
0.0M WL Water Level 0%

REM ; THERE ARE NO DEFECTS IN THIS SECTION OF PIPE
