Inspection Report

| Site; Tye Lane<br>Place: Warblington | | Division:<br>District: S.W<br>Tape No: 1 | | Start MH: S12.1<br>End MH: LAT 1<br>Total Length: | |
| Purpose:<br>Use:<br>Catchment: | Structural Defects<br>STORM<br>P1 Schedule | Size/Shape: Circular dia 100mm<br>Material: PLASTIC<br>Lining:<br>Category: | | | |

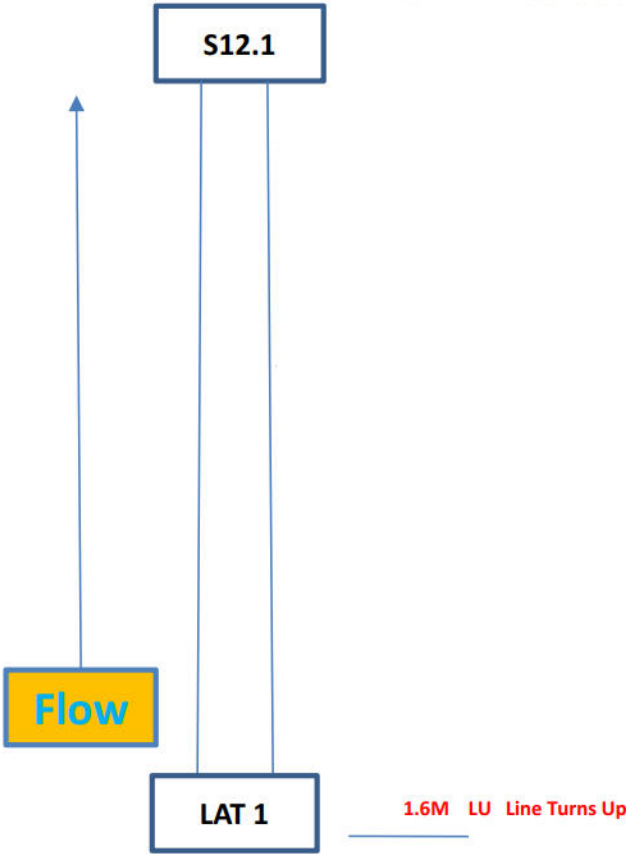
0.0M ST Start Of Survey  
0.0M WL Water Level 0%

REM ; THERE ARE NO DEFECTS IN THIS SECTION OF PIPE
