Inspection Report

| Site; Tye Lane<br>Place: Warblington | | Division:<br>District: S.W<br>Tape No: 1 | | Start MH: S12.1<br>End MH: LAT 2<br>Total Length: | |
| Purpose:<br>Use:<br>Catchment: | Structural Defects<br>STORM<br>P1 Schedule | Size/Shape: Circular dia 100mm<br>Material: PLASTIC<br>Lining:<br>Category: | | | |

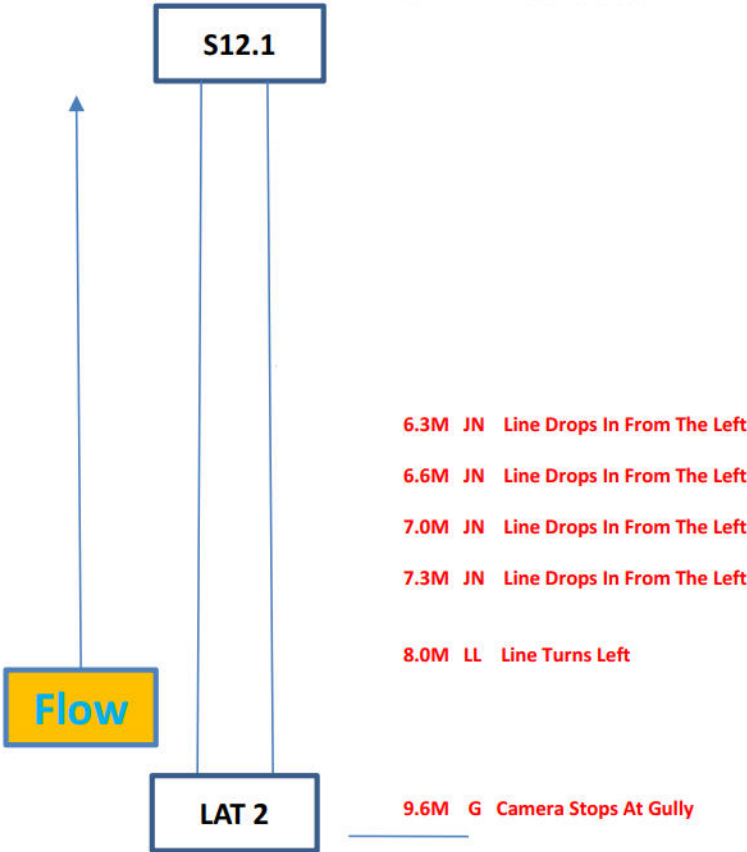
0.0M ST Start Of Survey  
0.0M WL Water Level 0%

REM ; THERE ARE NO DEFECTS IN THIS SECTION OF PIPE
