Inspection Report

| Site; Tye Lane<br>Place: Warblington | | Division:<br>District: S.W<br>Tape No: 1 | | Start MH: F31.2B<br>End MH: LAT 1<br>Total Length: | |
| Purpose:<br>Use:<br>Catchment: | Structural Defects<br>FOUL<br>P1 Schedule | Size/Shape: Circular dia 100mm<br>Material: PLASTIC<br>Lining:<br>Category: | | | |

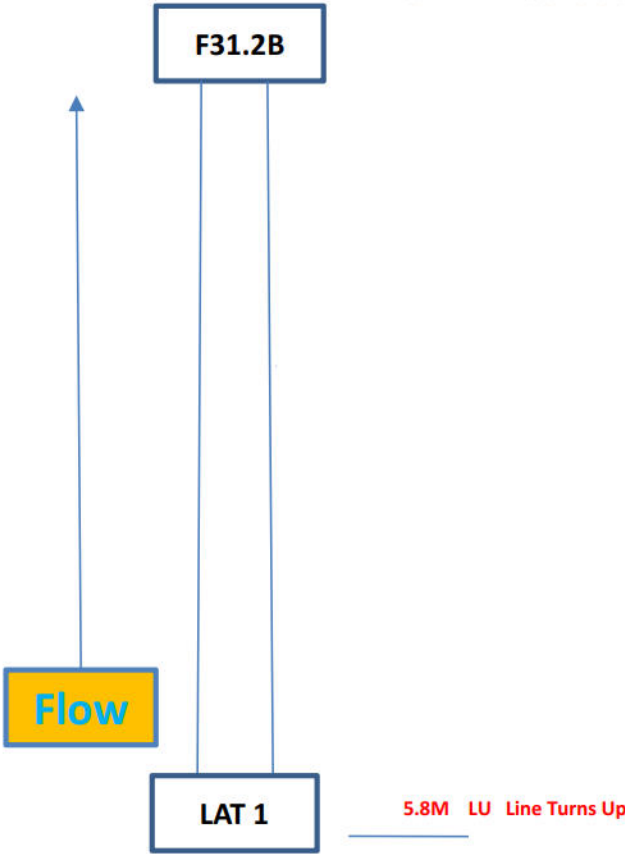
0.0M ST Start Of Survey  
0.0M WL Water Level 0%

REM ; THERE ARE NO DEFECTS WITH THIS SECTION OF PIPE
