Inspection Report

| Site; Tye Lane<br>Place: Warblington | | Division:<br>District: S.W<br>Tape No: 1 | | Start MH: S12.1<br>End MH: LAT 3<br>Total Length: | |
| Purpose:<br>Use:<br>Catchment: | Structural Defects<br>STORM<br>P1 Schedule | Size/Shape: Circular dia 100mm<br>Material: PLASTIC<br>Lining:<br>Category: | | | |

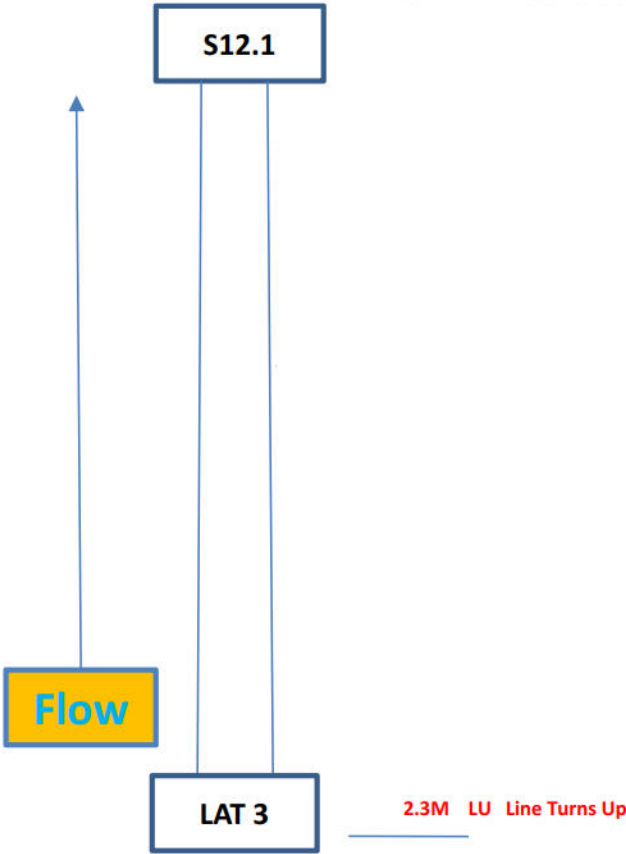
0.0M ST Start Of Survey  
0.0M WL Water Level 0%

REM ; THERE ARE NO DEFECTS IN THIS SECTION OF PIPE
