Inspection Report

| Site; Tye Lane<br>Place: Warblington | | Division:<br>District: S.W<br>Tape No: 1 | | Start MH: \$12.1<br>End MH: MAIN<br>Total Length: | |

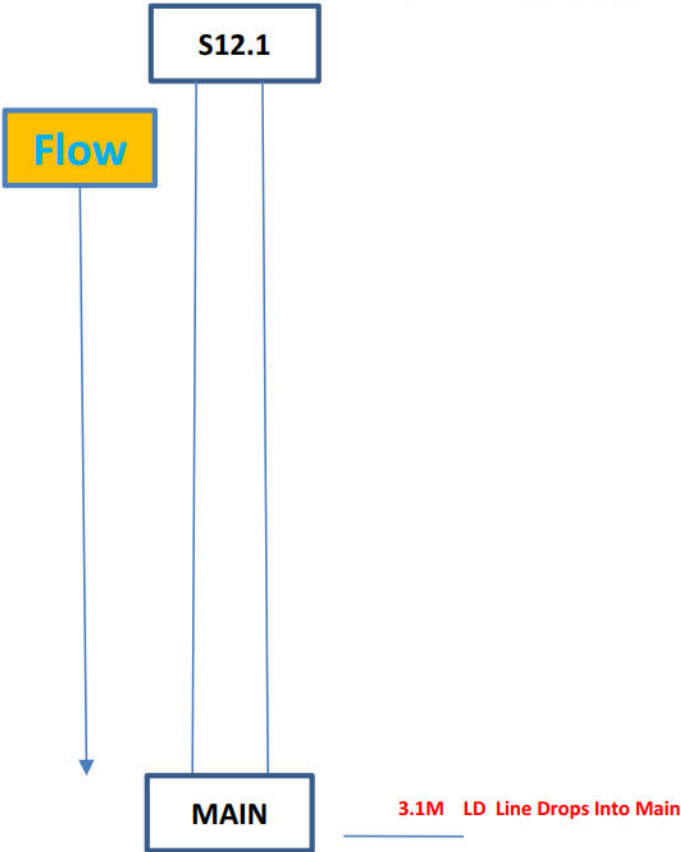
REM ; THERE ARE NO DEFECTS WITH THIS SECTION OF PIPE
