Inspection Report

| Site; Tye Lane<br>Place: Warblington | | Division:<br>District: S.W<br>Tape No: 1 | | Start MH: S11.1<br>End MH: MAIN<br>Total Length: | |

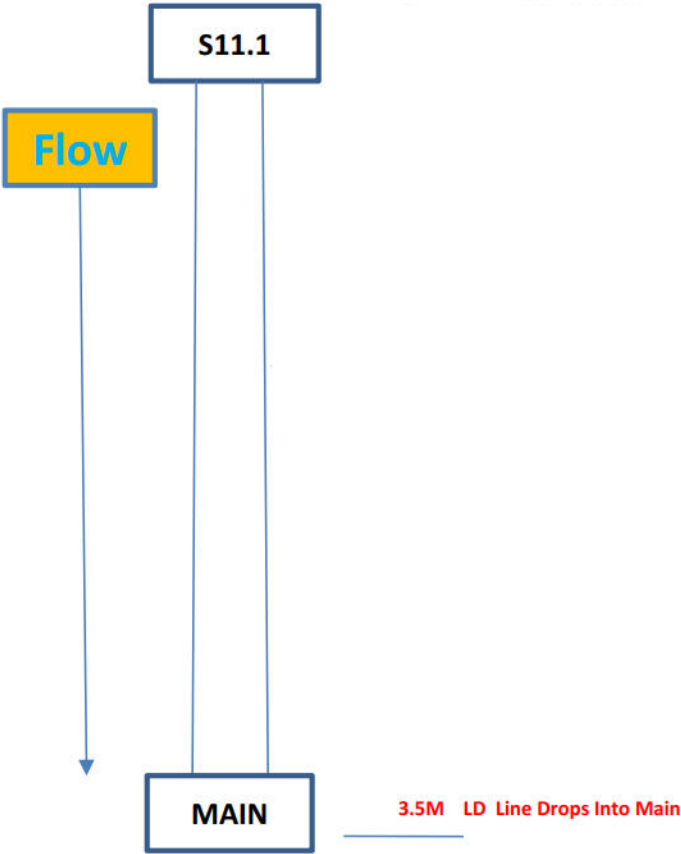
0.0M ST Start Of Survey  
0.0M WL Water Level 0%

REM ; THERE ARE NO DEFECTS WITH THIS SECTION OF PIPE
